Customer Id: VESTAS
Sample No.: WC0835224
Lab Number: 02590759
Test Package: IND 2

OIL ANALYSIS REPORT

Area
Saugeen Shores SP-17701
Machine ID
ECW #2
Component
Wind Turbine Gearbox
Fluid
MOBIL MOBILGEAR SHC XMP 320 (260 LTR)

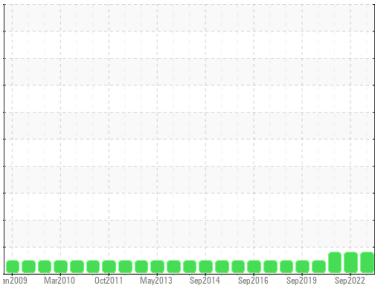
Sample Rating Trend

WEAR

▲ Non-ferrous Metals

Sample Status				**ABNORMAL**	ABNORMAL	ABNORMAL
Copper	ppm	ASTM D5185(m)	>5	▲ **6**	▲ 6	▲ 6

We recommend an early resample to monitor this condition.

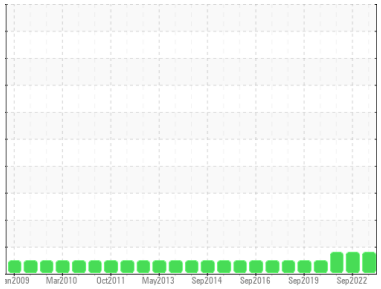
Sample Rating Trend

WEAR

Copper ppm levels are abnormal. Bearing and/or bushing wear is indicated.

We recommend an early resample to monitor this condition.

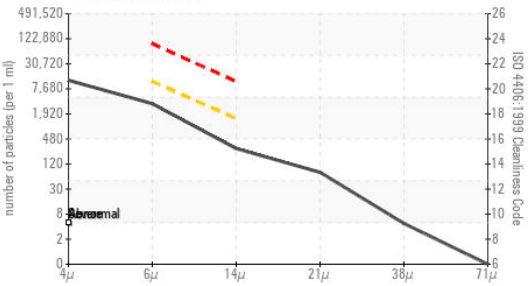
Particle Count

The system cleanliness is acceptable for your target ISO 4406 cleanliness code. The water content is negligible. The system and fluid cleanliness is acceptable.

FLUID CLEANLINESS		method	limit/base	current	history1	history2
Particles >4µm		ASTM D7647		**10740**	10950	5102
Particles >6µm		ASTM D7647	>10000	**2958**	2892	1104
Particles >14µm		ASTM D7647	>1300	**249**	165	63
Particles >21µm		ASTM D7647	>320	**67**	31	16
Particles >38µm		ASTM D7647	>80	**4**	1	1
Particles >71µm		ASTM D7647	>20	**0**	0	0
Oil Cleanliness		ISO 4406 (c)	>--/20/17	**21/19/15**	21/19/15	20/17/13

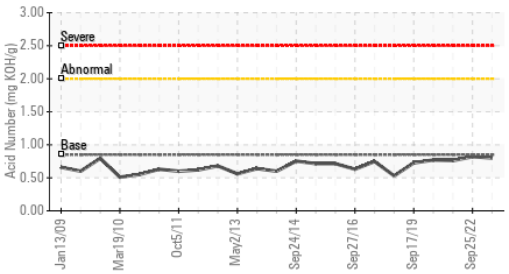
Acid Number

The AN level is acceptable for this fluid. The condition of the oil is suitable for further service.
