OIL ANALYSIS REPORT

Area
Hydro Extrusions - S08200
Machine Id
A2310124
Component
Hydraulic System
Fluid
NOT GIVEN (--- GAL)

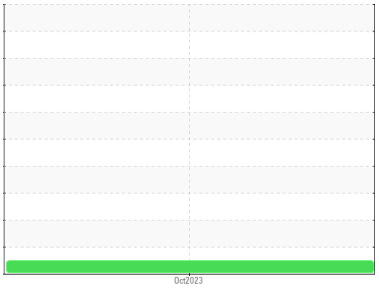
Sample Rating Trend

NORMAL

Contamination
The sample submitted is 8 times dirtier than the Hydro Extrusion ISO dirt count requirement of 16/14/11.

Recommendation
This is a baseline read-out on the submitted sample.

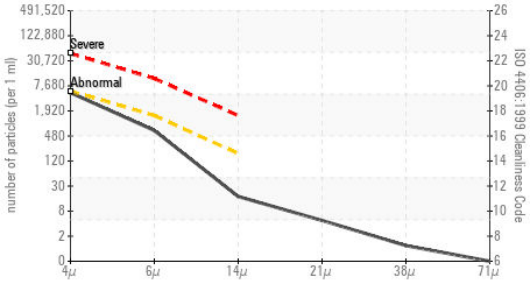
Particle Count

FLUID CLEANLINESS		method	limit/base	current	history1	history2
Particles >4µm		ASTM D7647	>5000	**4593**	---	---
Particles >6µm		ASTM D7647	>1300	**571**	---	---
Particles >14µm		ASTM D7647	>160	**15**	---	---
Particles >21µm		ASTM D7647	>40	**4**	---	---
Particles >38µm		ASTM D7647	>10	**1**	---	---
Particles >71µm		ASTM D7647	>3	**0**	---	---
Oil Cleanliness		ISO 4406 (c)	>19/17/14	**19/16/11**	---	---
