Customer Id: GOONAP
Sample No.: WC0851365
Lab Number: 02591015
Test Package: IND 2

OIL ANALYSIS REPORT

Area
Curing Department
Machine Id
PHC12
Component
Hydraulic System
Fluid
ISO 68 (200 GAL)

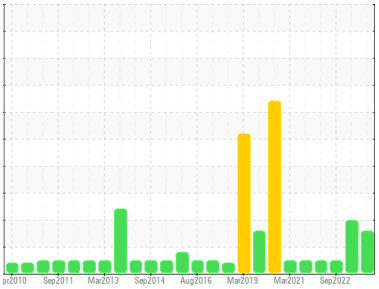
Sample Rating Trend

DIRT

Sample Status				ABNORMAL	ATTENTION	NORMAL
Silicon	ppm	ASTM D5185(m)	>15	▲ 58	15	17

Check seals and/or filters for points of contaminant entry. The air breather requires service. If unrated, we recommend that you replace with a suitable micron rated and/or desiccant air breather. If rated, we recommend that you service/replace the breather. We recommend an early resample to monitor this condition. Please specify the brand, type, and viscosity of the oil on your next sample.

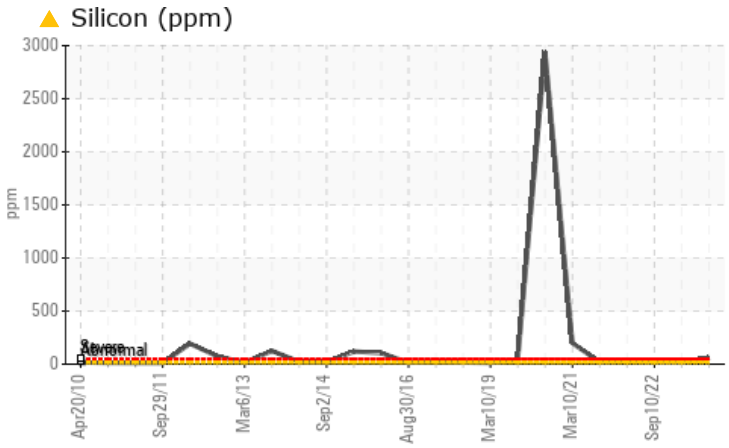
COMPONENT CONDITION SUMMARY

Elemental level of silicon (Si) above normal indicating ingress of seal material and/or dirt.

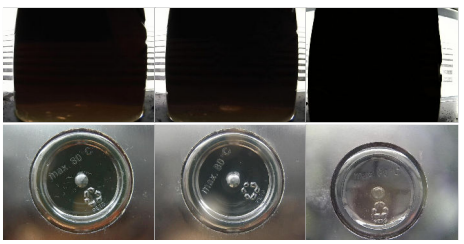
SAMPLE IMAGES	method	limit/base	current	history1	history2
Color					
Bottom

VISUAL		method	limit/base	current	history1	history2
White Metal	scalar	Visual*	NONE	**NONE**	NONE	NONE
Yellow Metal	scalar	Visual*	NONE	**NONE**	NONE	NONE
Precipitate	scalar	Visual*	NONE	**NONE**	NONE	NONE
Silt	scalar	Visual*	NONE	**NONE**	NONE	NONE
Debris	scalar	Visual*	NONE	**NONE**	NONE	NONE
Sand/Dirt	scalar	Visual*	NONE	**NONE**	NONE	NONE
Appearance	scalar	Visual*	NORML	**NORML**	NORML	NORML
Odor	scalar	Visual*	NORML	**NORML**	NORML	NORML
Emulsified Water	scalar	Visual*	>0.05	**NEG**	NEG	NEG
Free Water	scalar	Visual*		**NEG**	NEG	NEG
