Customer Id: GOONAP
Sample No.: WC0851369
Lab Number: 02591025
Test Package: IND 2

OIL ANALYSIS REPORT

Area
Curing Department
Machine Id
PHC16
Component
Hydraulic System
Fluid
ISO 68 (200 GAL)

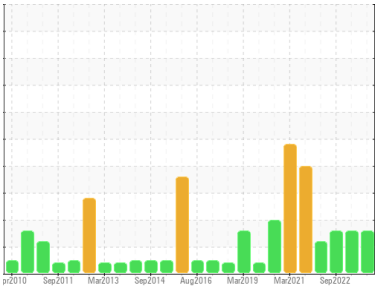
Sample Rating Trend

DIRT

Sample Status				ABNORMAL	ABNORMAL	ATTENTION
Silicon	ppm	ASTM D5185(m)	>15	▲ 97	15	15

Check seals and/or filters for points of contaminant entry. The air breather requires service. If unrated, we recommend that you replace with a suitable micron rated and/or desiccant air breather. If rated, we recommend that you service/replace the breather. We recommend an early resample to monitor this condition. Please specify the brand, type, and viscosity of the oil on your next sample.

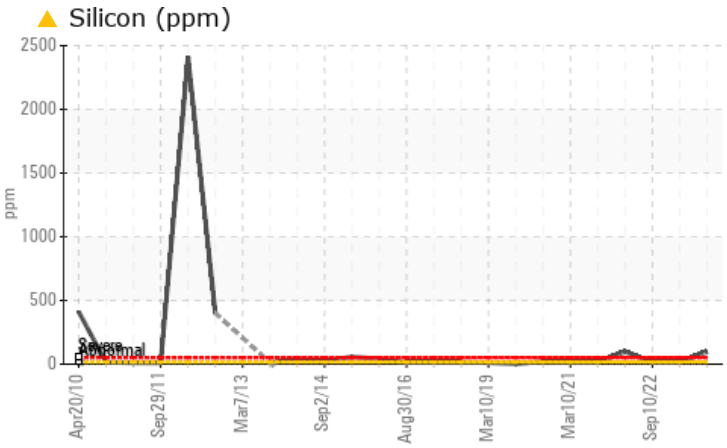
COMPONENT CONDITION SUMMARY

All component wear rates are normal. Suspect wear metal(s) are high due to process contamination.

Abnormal element levels due to process contamination.

The AN level is acceptable for this fluid. The oil is still serviceable provided that the contaminant(s) can be reduced to acceptable levels.

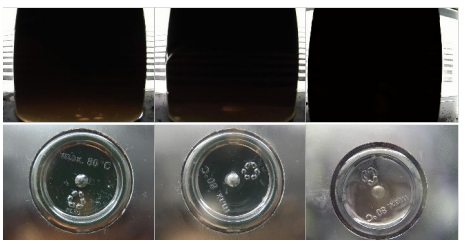
SAMPLE IMAGES	method	limit/base	current	history1	history2
Color					
Bottom

VISUAL		method	limit/base	current	history1	history2
White Metal	scalar	Visual*	NONE	**NONE**	NONE	NONE
Yellow Metal	scalar	Visual*	NONE	**NONE**	NONE	NONE
Precipitate	scalar	Visual*	NONE	**NONE**	NONE	NONE
Silt	scalar	Visual*	NONE	**VLITE**	NONE	NONE
Debris	scalar	Visual*	NONE	**NONE**	VLITE	NONE
Sand/Dirt	scalar	Visual*	NONE	**NONE**	NONE	NONE
Appearance	scalar	Visual*	NORML	**NORML**	NORML	NORML
Odor	scalar	Visual*	NORML	**NORML**	NORML	NORML
Emulsified Water	scalar	Visual*	>0.05	**NEG**	NEG	NEG
Free Water	scalar	Visual*		**NEG**	NEG	NEG
