PROBLEM SUMMARY

Area
Hydraulic System in Plant [412507817]
Machine Id
Combo Dumper SRM - Maximo #6259 1000052942 (S/N 0504516)
Component
Hydraulic System
Fluid
TOTAL FINA NEVASTANE FG AW 46 (10 GAL)

OIL ANALYSIS REPORT

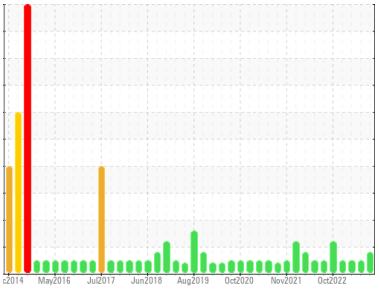
Sample Rating Trend

ISO

Sample Status				**ATTENTION**	NORMAL	NORMAL
Particles >4µm		ASTM D7647	>5000	▲ **5212**	3899	3934
Oil Cleanliness		ISO 4406 (c)	>19/17/14	▲ **20/17/13**	19/17/13	19/16/12

We recommend you service the filters on this component. Resample at the next service interval to monitor.

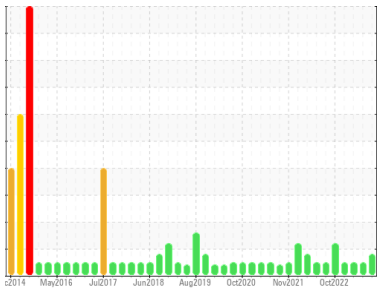
Sample Rating Trend

Contamination
There is a light amount of silt (particulates < 14 microns in size) present in the oil.

FLUID CLEANLINESS		method	limit/base	current	history1	history2
Particles >4µm		ASTM D7647	>5000	▲ **5212**	3899	3934
Particles >6µm		ASTM D7647	>1300	**898**	928	332
Particles >14µm		ASTM D7647	>160	**74**	60	21
Particles >21µm		ASTM D7647	>40	**17**	13	8
Particles >38µm		ASTM D7647	>10	**2**	1	1
Particles >71µm		ASTM D7647	>3	**1**	0	1
Oil Cleanliness		ISO 4406 (c)	>19/17/14	▲ **20/17/13**	19/17/13	19/16/12

Recommendation
We recommend you service the filters on this component. Resample at the next service interval to monitor.
