PROBLEM SUMMARY

Area
GAS COMPRESSION [02591388]
Machine Id
36-T-1910B (36-K-1900B)
Component
Turbine
Fluid
MOBIL DTE 846 (--- LTR)

OIL ANALYSIS REPORT

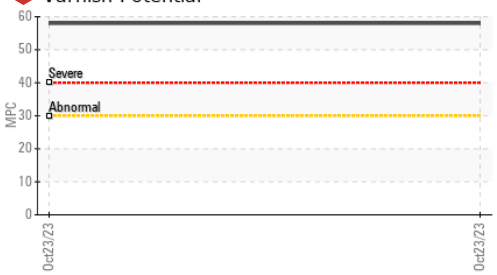
Varnish Potential

MPC (Membrane Patch Colorimetry) test indicates a high concentration of varnish present. The system cleanliness is acceptable for your target ISO 4406 cleanliness code. The water content is negligible.

We recommend that you perform vacuum distillation and/or air drying to attempt to remove any residual water and/or entrained gases from this oil that may be contributing to abnormal foaming and/or poor water separability. We recommend that you use electrostatic filtration to remove insolubles from the oil and to reduce the levels of varnish in the system. Alternatively draining a percentage of the oil and topping up with fresh oil (sweetening the oil) may provide a reduction in the varnish potential level. We recommend an early resample to monitor this condition. NOTE: Please provide information regarding reservoir capacity, filter type and micron rating with next sample.

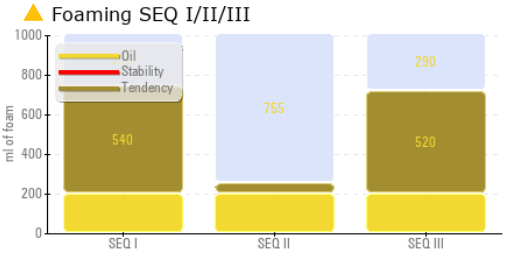
Foaming SEQ I/II/III

Foaming Tendency (ASTM D892) results are abnormal indicating a tendency for oil foaming. Rust Prevention test (ASTM D665) indicates the oil retains good anti-corrosion properties. The AN level is acceptable for this fluid.

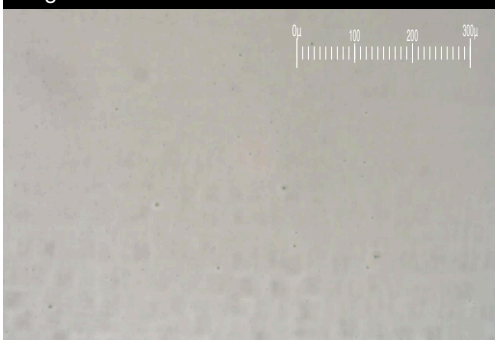
All component wear rates are normal. The ferrography results are normal indicating no abnormal wear in the system.
