PROBLEM SUMMARY

Area
WATER INJECTION [02592052]
Machine Id
44-T-2550B (44-P-2540B)
Component
Turbine
Fluid
MOBIL DTE 832 (--- LTR)

OIL ANALYSIS REPORT

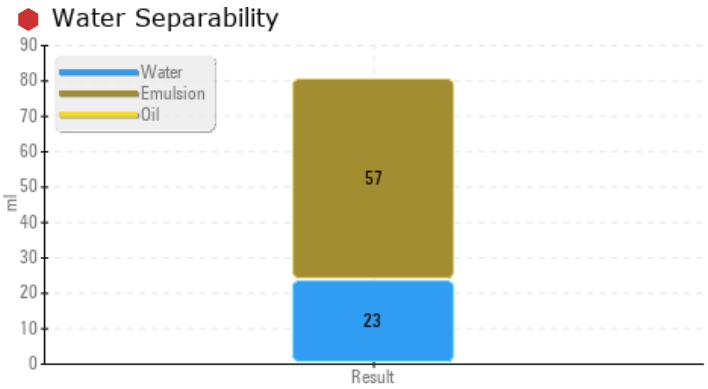
COMPONENT CONDITION SUMMARY

Sample Status				**SEVERE**	---	---
Separability	oil/h2o/em	ASTM D1401*	40/40/0	**0/23/57 (30)**	---	---

Water Separability results (ASTM D1401) are poor and indicate that the oil will form emulsions with water. The system cleanliness is acceptable for your target ISO 4406 cleanliness code. The water content is negligible.

We recommend that you perform vacuum distillation and/or air drying to attempt to remove any residual water and/or entrained gases from this oil that may be contributing to abnormal foaming and/or poor water separability. We recommend an early resample to monitor this condition. NOTE: Please provide information regarding reservoir capacity, filter type and micron rating with next sample.

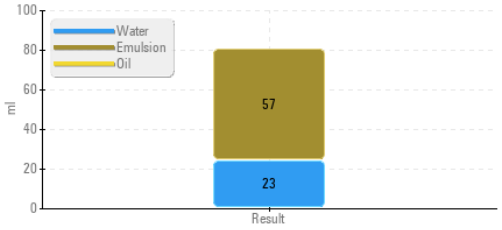
Water Separability

FLUID PROPERTIES		method	limit/base	current	history1	history2
Visc @ 40°C	cSt	ASTM D7279(m)	29.6	**30.6**	---	---
Visc @ 100°C	cSt	ASTM D7279(m)	5.4	**5.7**	---	---
Viscosity Index (VI)	Scale	ASTM D2270*	110	**128**	---	---
Separability	oil/h2o/em	ASTM D1401*	40/40/0	**0/23/57 (30)**	---	---
Air Release Time	min	ASTM D3427*	2	**3.70**	---	---
Foam Tendency	I/II/III	ASTM D892*	20	**470/50/430**	---	---
Foam Stability	I/II/III	ASTM D892*	0	**0/0/0**	---	---
ASTM Color	scalar	ASTM D1500*		**5.5**	---	---
Rust Prevention	PASS/FAIL	ASTM D665*	PASS	**PASS**	---	---
Oxidation Test (RPVOT)	minutes	ASTM D2272*	1200	**1331**	---	---

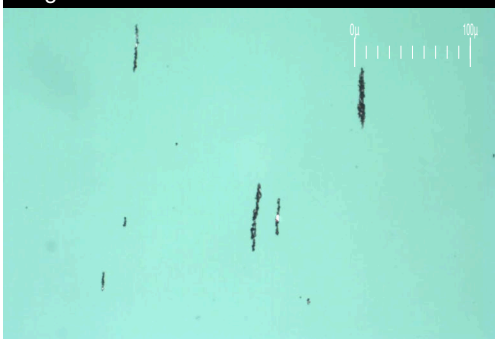
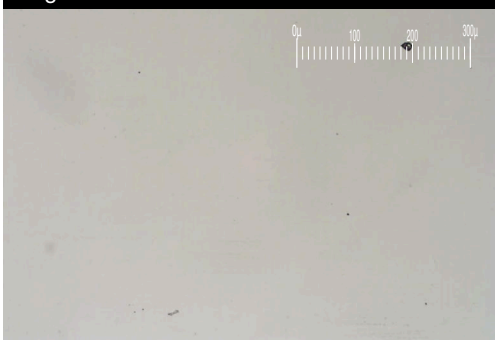
Magn: 200x Illum: BC

All component wear rates are normal. The ferrography results are normal indicating no abnormal wear in the system.

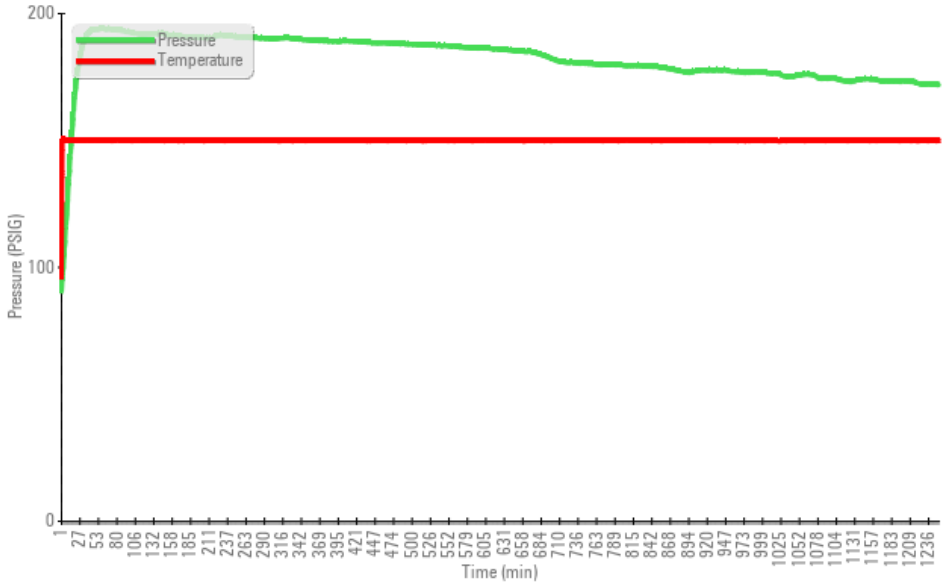
Rotating Pressure Vessel Oxidation Test

Rust Prevention test (ASTM D665) indicates the oil retains good anti-corrosion properties. The AN level is acceptable for this fluid.
