Customer Id: MAKMOU
Sample No.: WC0814813
Lab Number: 02591445
Test Package: AOM 3

OIL ANALYSIS REPORT

Area
GAS COMPRESSION [02591388]
Machine Id
36-T-1910A (36-K-1900A)
Component
Turbine
Fluid
MOBIL DTE 846 (--- LTR)

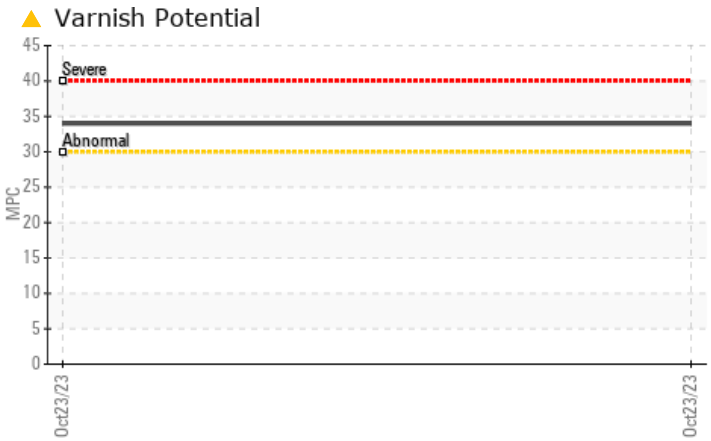
COMPONENT CONDITION SUMMARY

Sample Status				**ABNORMAL**	---	---
MPC Varnish Potential	Scale	ASTM D7843(m)*	>15	▲ **34**	---	---
Foam Tendency	I/II/III	ASTM D892*	20	▲ **550/50/540**	---	---

MPC (Membrane Patch Colorimetry) test indicates a moderate concentration of varnish present. The system cleanliness is acceptable for your target ISO 4406 cleanliness code. The water content is negligible.

Foaming Tendency (ASTM D892) results are abnormal indicating a tendency for oil foaming. Rust Prevention test (ASTM D665) indicates the oil retains good anti-corrosion properties. The AN level is acceptable for this fluid.

We recommend that you perform vacuum distillation and/or air drying to attempt to remove any residual water and/or entrained gases from this oil that may be contributing to abnormal foaming and/or poor water separability. We recommend that you use electrostatic filtration to remove insolubles from the oil and to reduce the levels of varnish in the system. Alternatively draining a percentage of the oil and topping up with fresh oil (sweetening the oil) may provide a reduction in the varnish potential level. We recommend an early resample to monitor this condition. NOTE: Please provide information regarding reservoir capacity, filter type and micron rating with next sample.

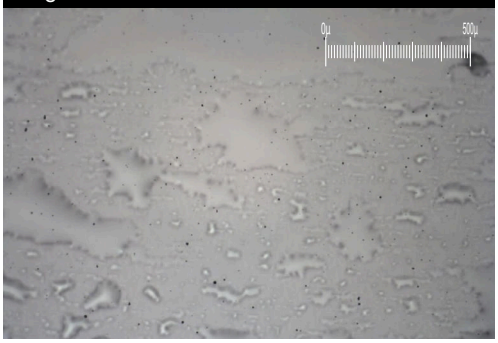
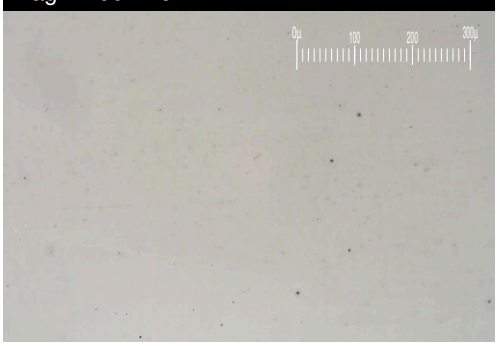
All component wear rates are normal. The ferrography results are normal indicating no abnormal wear in the system.
