PROBLEM SUMMARY

Area
MPG GENERATOR [02591388]
Machine Id
71-T-3580A (71-G-3300A)
Component
Turbine
Fluid
MOBIL DTE 846 (--- LTR)

OIL ANALYSIS REPORT

FERROGRAPHY REPORT

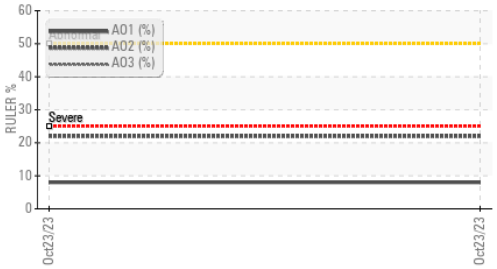
Remaining Life (RULER)

Linear Sweep Voltammetry (RULER– ASTM D6971) testing indicates both anti-oxidants present in the oil will soon be depleted. Viscosity of sample indicates oil is within ISO 22 range, advise investigate. Rust Prevention test (ASTM D665) indicates the oil retains good anti-corrosion properties. The AN level is acceptable for this fluid.

Action	Status	Date	Done By	Description
Service/change Fluid	---	---	?	The oil is near the end of it's useful service life, recommend schedule an oil change.
Resample	---	---	?	We recommend an early resample to monitor this condition.
Alert	---	---	?	The fluid was specified as MOBIL DTE 846, however, a fluid match indicates that this fluid is Phosphate Ester (PE) Turbine Oil. Please confirm the oil type and grade on your next sample.
Information Required	---	---	?	NOTE: Please provide information regarding reservoir capacity, filter type and micron rating with next sample.
Check Breathers	---	---	?	The air breather requires service. If unrated, we recommend that you replace with a suitable micron rated and/or desiccant air breather. If rated, we recommend that you service/replace the breather.
Check Water Access	---	---	?	We advise that you check for the source of water entry.
Check Seals	---	---	?	Check seals and/or filters for points of contaminant entry.

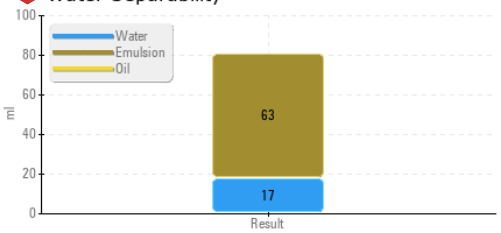
Water Separability results (ASTM D1401) are poor and indicate that the oil will form emulsions with water. There is a moderate concentration of water present in the oil. The system cleanliness is acceptable for your target ISO 4406 cleanliness code.

We recommend that you perform vacuum distillation and/or air drying to attempt to remove any residual water and/or entrained gases from this oil that may be contributing to abnormal foaming and/or poor water separability. We advise that you check for the source of water entry. Check seals and/or filters for points of contaminant entry. The oil is near the end of it`s useful service life, recommend schedule an oil change. The air breather requires service. If unrated, we recommend that you replace with a suitable micron rated and/or desiccant air breather. If rated, we recommend that you service/replace the breather. We advise that you use off-line filtration with water adsorbent filters to attempt to remove the water from this oil. We recommend an early resample to monitor this condition. The fluid was specified as MOBIL DTE 846, however, a fluid match indicates that this fluid is Phosphate Ester (PE) Turbine Oil. Please confirm the oil type and grade on your next sample. NOTE: Please provide information regarding reservoir capacity, filter type and micron rating with next sample.

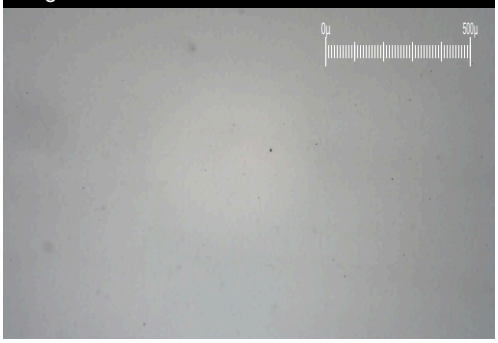
Magn: 50x Illum: RW

All component wear rates are normal. The ferrography results are normal indicating no abnormal wear in the system.
