Customer Id: VESTAS
Sample No.: WC0835304
Lab Number: 02591542
Test Package: IND 2

OIL ANALYSIS REPORT

Area
Saugeen Shores SP-17701
Machine ID
05K02 (S/N 24014)
Component
Wind Turbine Gearbox
Fluid
MOBIL MOBILGEAR SHC XMP 320 (260 LTR)

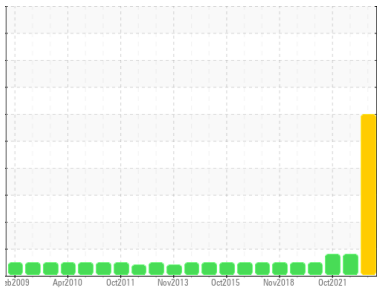
Sample Rating Trend

Copper ppm levels are severe. Bearing and/or bushing wear is indicated.

Resample at the next service interval to monitor. Re-sampling is suggested to confirm test results prior to significant maintenance activities being performed. Please indicate that this is a resample on your Sample Information Form (SIF).

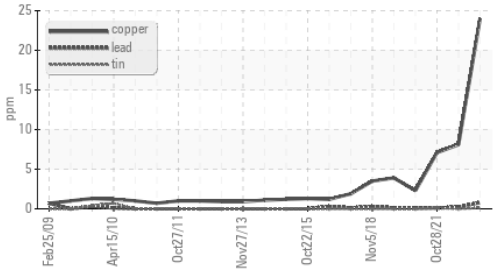
Non-ferrous Metals

Sample Status				SEVERE	ABNORMAL	ABNORMAL
Copper	ppm	ASTM D5185(m)	>5	24	8	7

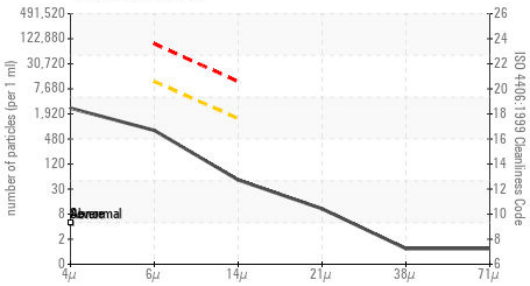
Particle Count

The system cleanliness is acceptable for your target ISO 4406 cleanliness code. The water content is negligible. The system and fluid cleanliness is acceptable.

FLUID CLEANLINESS		method	limit/base	current	history1	history2
Particles >4µm		ASTM D7647		**2310**	4655	1995
Particles >6µm		ASTM D7647	>10000	**677**	1073	373
Particles >14µm		ASTM D7647	>1300	**44**	81	33
Particles >21µm		ASTM D7647	>320	**9**	28	11
Particles >38µm		ASTM D7647	>80	**1**	2	1
Particles >71µm		ASTM D7647	>20	**1**	0	0
Oil Cleanliness		ISO 4406 (c)	>--/20/17	**18/17/13**	19/17/14	18/16/12

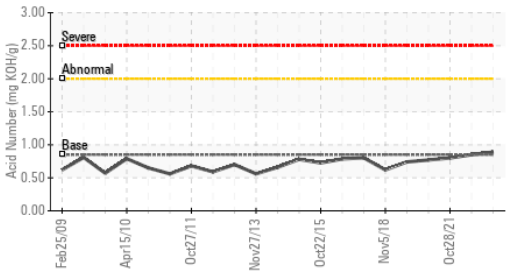
The AN level is acceptable for this fluid. The condition of the oil is suitable for further service.

FLUID DEGRADATION		method	limit/base	current	history1	history2
Oxidation	Abs/.1mm	ASTM D7414*		**54.8**	22.1	53.0
Acid Number (AN)	mg KOH/g	ASTM D974*	0.85	**0.89**	0.85	0.80
