Customer Id: STMBOW
Sample No.: WC0851467
Lab Number: 02591873
Test Package: IND 2

OIL ANALYSIS REPORT

Area
3
Machine Id
3-101-MG Primary
Component
Crusher
Fluid
MOBIL MOBILGEAR 600 XP 320 (2900 LTR)

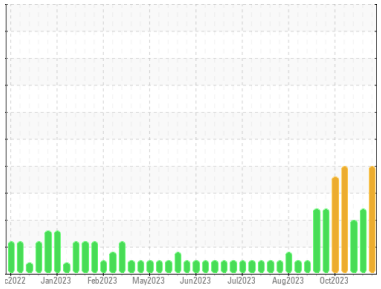
Sample Rating Trend

WATER

We advise that you check for the source of water entry. Check seals and/or filters for points of contaminant entry. The air breather requires service. If unrated, we recommend that you replace with a suitable micron rated and/or desiccant air breather. If rated, we recommend that you service/replace the breather. We advise that you use off-line filtration with water adsorbent filters to attempt to remove the water from this oil. We advise that you perform a filter service, and use off-line filtration to improve the cleanliness of the system fluid. Confirm the source of the lubricant being utilized for top-up/fill. We recommend an early resample to monitor this condition. Please contact your representative for information regarding the proper sampling kits for your service. NOTE: We recommend using IND 3 test kits, this testkit includes Analytical Ferrography which provides a detailed morphological analysis of wear particles present in the fluid.

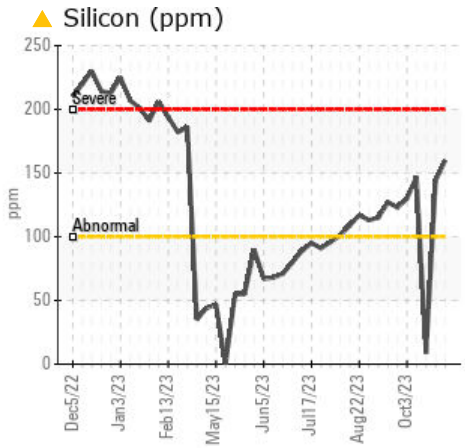
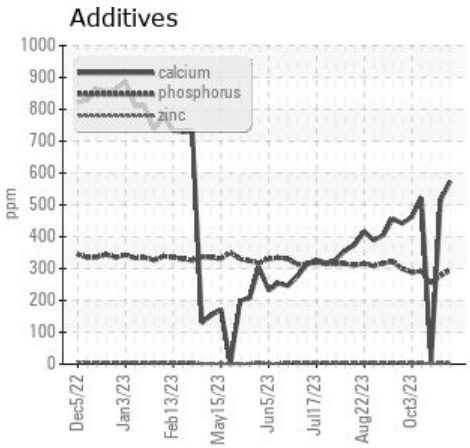
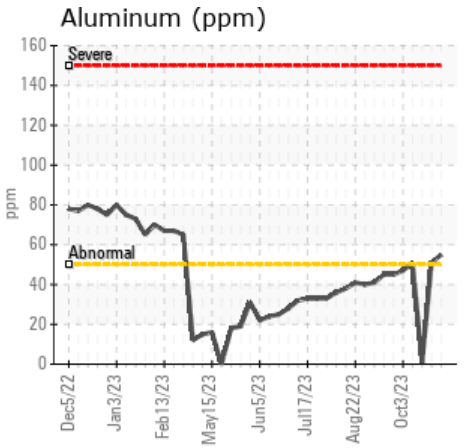
COMPONENT CONDITION SUMMARY

Free water present. Elemental levels of silicon (Si) and aluminum (Al) indicate alumina-silicate (coarse dirt) ingress.

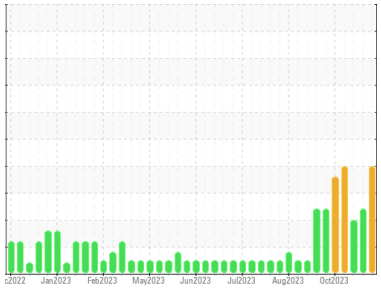
Sample Rating Trend

WATER

We advise that you check for the source of water entry. Check seals and/or filters for points of contaminant entry. The air breather requires service. If unrated, we recommend that you replace with a suitable micron rated and/or desiccant air breather. If rated, we recommend that you service/replace the breather. We advise that you use off-line filtration with water adsorbent filters to attempt to remove the water from this oil. We advise that you perform a filter service, and use off-line filtration to improve the cleanliness of the system fluid. Confirm the source of the lubricant being utilized for top-up/fill. We recommend an early resample to monitor this condition. Please contact your representative for information regarding the proper sampling kits for your service. NOTE: We recommend using IND 3 test kits, this testkit includes Analytical Ferrography which provides a detailed morphological analysis of wear particles present in the fluid.

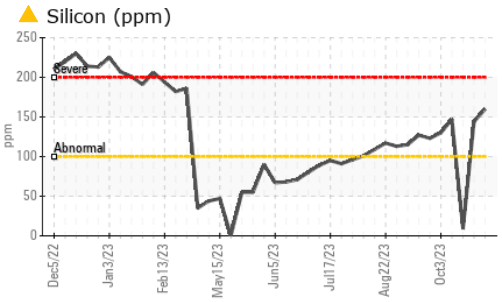
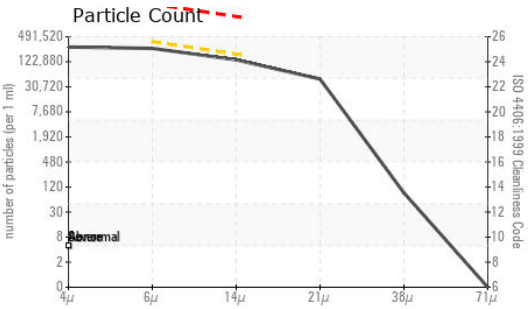
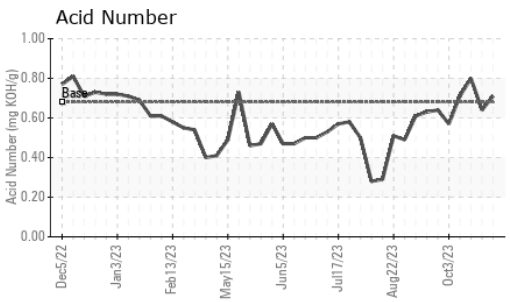
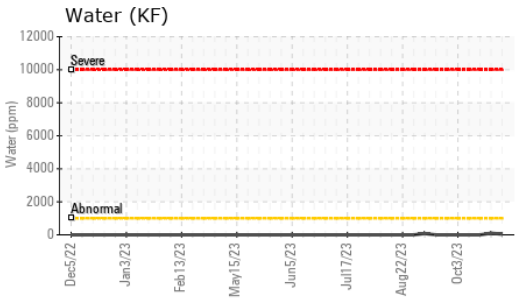
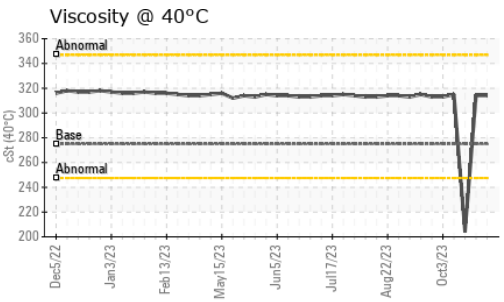
Additive levels indicate the addition of a different brand, or type of oil. The AN level is acceptable for this fluid. The oil is still serviceable provided that the contaminant(s) can be reduced to acceptable levels.
