OIL ANALYSIS REPORT

Area
SAB2
Machine Id
SAB2 G20 Governor
Component
Hydraulic System
Fluid
ESSO TERESSO ISO 46 (6160 LTR)

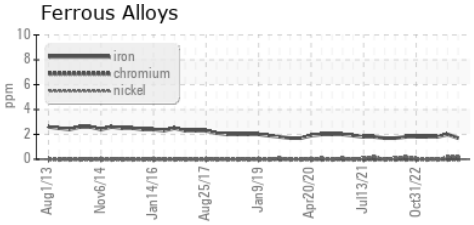
Ferrous Alloys

Wear
Component wear rates appear to be normal (unconfirmed).

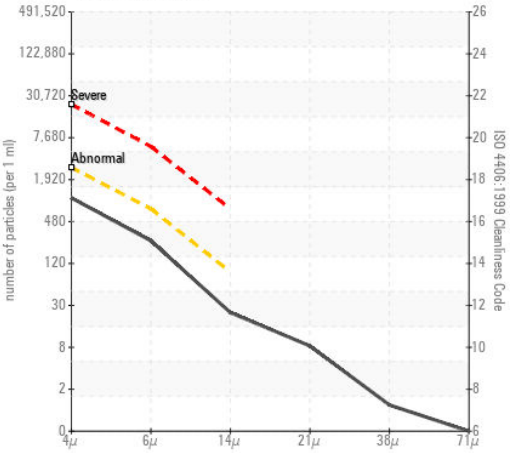
Particle Count

Contamination
The system cleanliness is acceptable for your target ISO 4406 cleanliness code. The system and fluid cleanliness is acceptable.

FLUID CLEANLINESS		method	limit/base	current	history1	history2
Particles >4µm		ASTM D7647	>2500	**920**	1189	426
Particles >6µm		ASTM D7647	>640	**224**	255	116
Particles >14µm		ASTM D7647	>80	**21**	13	8
Particles >21µm		ASTM D7647	>20	**7**	3	2
Particles >38µm		ASTM D7647	>4	**1**	0	0
Particles >71µm		ASTM D7647	>3	**0**	0	0
Oil Cleanliness		ISO 4406 (c)	>18/16/13	**17/15/12**	17/15/11	16/14/10

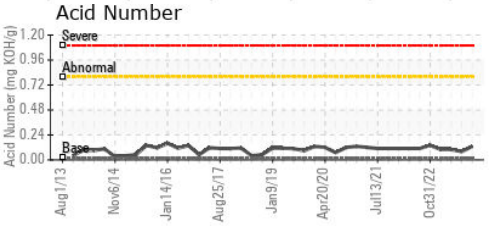
Fluid Condition
The AN level is acceptable for this fluid. The condition of the oil is suitable for further service.

FLUID DEGRADATION		method	limit/base	current	history1	history2
Acid Number (AN)	mg KOH/g	ASTM D974*	0.02	**0.13**	0.08	0.10
