PROBLEM SUMMARY

Area
SAB2
Machine Id
SAB2 G22 Governor
Component
Hydraulic System
Fluid
ESSO TERESSO ISO 46 (6160 LTR)

Customer Id: ONTQUE
Sample No.: WC0858095
Lab Number: 02592063
Test Package: IND 2

OIL ANALYSIS REPORT

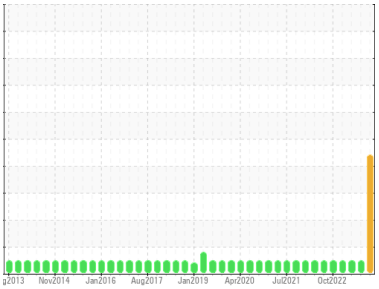
Sample Rating Trend

WATER

There is a moderate amount of silt (particulates < 14 microns in size) present in the oil. Free water present. The system cleanliness is above the acceptable limit for the target ISO 4406 cleanliness code.

We advise that you check for the source of water entry. Check seals and/or filters for points of contaminant entry. The air breather requires service. If unrated, we recommend that you replace with a suitable micron rated and/or desiccant air breather. If rated, we recommend that you service/replace the breather. We advise that you follow the water drain-off procedure for this component. We recommend you service the filters on this component. We recommend an early resample to monitor this condition.

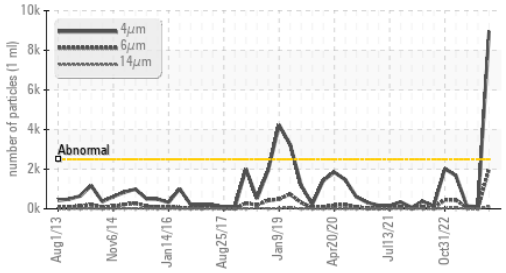
Particle Trend

FLUID CLEANLINESS	method	limit/base	current	history1	history2
Particles >4µm	ASTM D7647	>2500	▲ **8958**	108	138
Particles >6µm	ASTM D7647	>640	▲ **2015**	30	50
Particles >14µm	ASTM D7647	>80	▲ **107**	5	7
Particles >21µm	ASTM D7647	>20	▲ **30**	1	2
Particles >38µm	ASTM D7647	>4	**4**	0	0
Particles >71µm	ASTM D7647	>3	**0**	0	0
Oil Cleanliness	ISO 4406 (c)	>18/16/13	▲ **20/18/14**	14/12/10	14/13/10

We advise that you check for the source of water entry. Check seals and/or filters for points of contaminant entry. The air breather requires service. If unrated, we recommend that you replace with a suitable micron rated and/or desiccant air breather. If rated, we recommend that you service/replace the breather. We advise that you follow the water drain-off procedure for this component. We recommend you service the filters on this component. We recommend an early resample to monitor this condition.

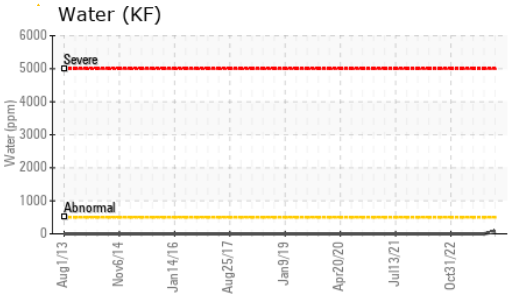
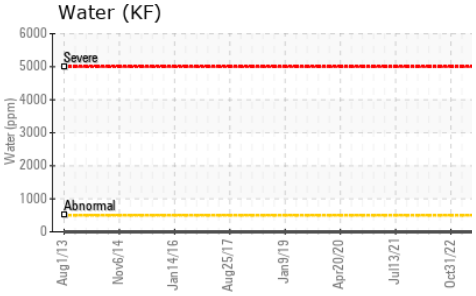
Water (KF)

CONTAMINANTS		method	limit/base	current	history1	history2
Silicon	ppm	ASTM D5185(m)	>15	**0**	0	0
Sodium	ppm	ASTM D5185(m)		**0**	0	0
Potassium	ppm	ASTM D5185(m)	>20	**0**	<1	<1
Water	%	ASTM D6304*	>0.05	**0.007**	---	---
ppm Water	ppm	ASTM D6304*	>500	**72.7**	---	---

VISUAL		method	limit/base	current	history1	history2
White Metal	scalar	Visual*	NONE	**NONE**	NONE	NONE
Yellow Metal	scalar	Visual*	NONE	**NONE**	NONE	NONE
Precipitate	scalar	Visual*	NONE	**NONE**	NONE	NONE
Silt	scalar	Visual*	NONE	**VLITE**	NONE	NONE
Debris	scalar	Visual*	NONE	**NONE**	NONE	NONE
Sand/Dirt	scalar	Visual*	NONE	**NONE**	NONE	NONE
Appearance	scalar	Visual*	NORML	▲ **WGOIL**	NORML	NORML
Odor	scalar	Visual*	NORML	**NORML**	NORML	NORML
Emulsified Water	scalar	Visual*	>0.05	**.5%**	NEG	NEG
Free Water	scalar	Visual*		▲ **1%**	NEG	NEG

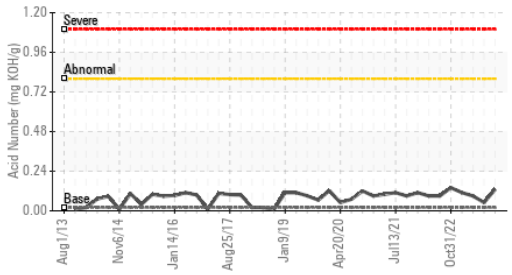
Acid Number

The AN level is acceptable for this fluid. The oil is still serviceable provided that the contaminant(s) can be reduced to acceptable levels.
