Customer Id: ONTQUE
Sample No.: WC0858058
Lab Number: 02592108
Test Package: IND 2

OIL ANALYSIS REPORT

Area
SAB2
Machine Id
SAB2 G11
Component
Turbine Bearing
Fluid
ESSO TERESSO ISO 46 (273 LTR)

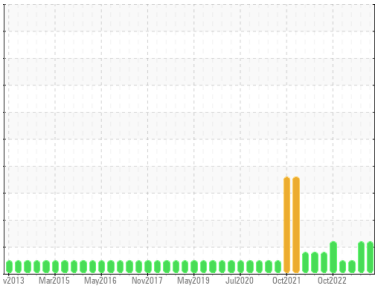
Sample Rating Trend

Sample Status				ATTENTION	ABNORMAL	NORMAL
Particles >4µm		ASTM D7647	>10000	▲ **15979**	▲ 44421	7516
Particles >6µm		ASTM D7647	>1300	▲ **1897**	▲ 7924	670
Oil Cleanliness		ISO 4406 (c)	>20/17/14	▲ **21/18/11**	▲ 23/20/14	20/17/11

We recommend you service the filters on this component. Resample at the next service interval to monitor.
