PROBLEM SUMMARY

Area
SAB2
Machine Id
SAB2 G13
Component
Thrust Bearing
Fluid
ESSO TERESSO ISO 46 (3182 LTR)

OIL ANALYSIS REPORT

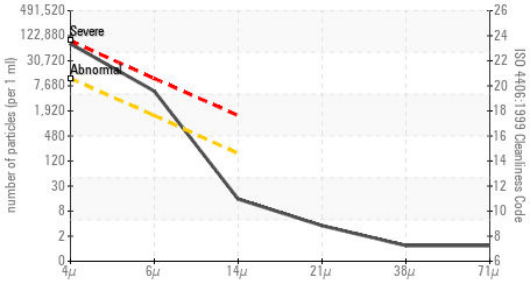
Particle Count

FLUID CLEANLINESS		method	limit/base	current	history1	history2
Particles >4µm		ASTM D7647	>10000	▲ **68021**	▲ 69576	▲ 69517
Particles >6µm		ASTM D7647	>1300	▲ **4988**	▲ 7614	▲ 7071
Particles >14µm		ASTM D7647	>160	**13**	26	55
Particles >21µm		ASTM D7647	>40	**3**	6	10
Particles >38µm		ASTM D7647	>10	**1**	0	1
Particles >71µm		ASTM D7647	>3	**1**	0	0
Oil Cleanliness		ISO 4406 (c)	>20/17/14	▲ **23/19/11**	▲ 23/20/12	▲ 23/20/13

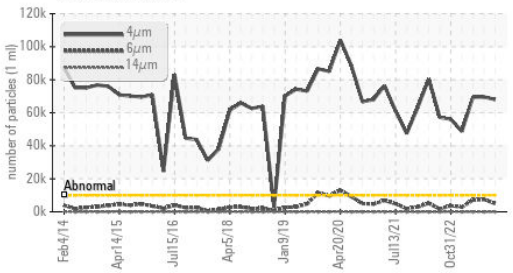
Particle Trend

There is a moderate amount of silt (particulates < 14 microns in size) present in the oil. The system cleanliness is above the acceptable limit for the target ISO 4406 cleanliness code.

We recommend you service the filters on this component. We recommend an early resample to monitor this condition. Please contact your representative for information regarding the proper sampling kits for your service. NOTE: We recommend using IND 3 test kits, this testkit includes Analytical Ferrography which provides a detailed morphological analysis of wear particles present in the fluid.

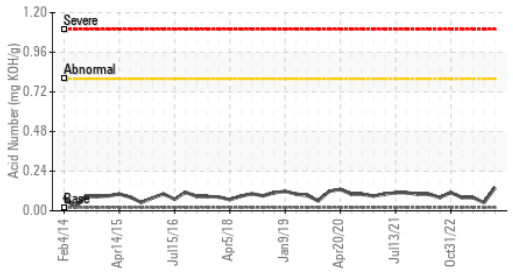
The AN level is acceptable for this fluid. The oil is still serviceable provided that the contaminant(s) can be reduced to acceptable levels.

FLUID DEGRADATION		method	limit/base	current	history1	history2
Acid Number (AN)	mg KOH/g	ASTM D974*	0.02	**0.14**	0.05	0.08

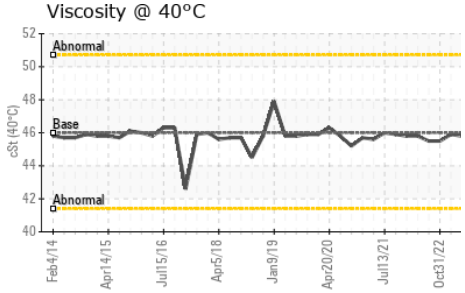
Viscosity @ 40°C

FLUID PROPERTIES		method	limit/base	current	history1	history2
Visc @ 40°C	cSt	ASTM D7279(m)	46	**45.5**	45.6	45.8
