Area
ENGINE ROOM FLOOR
Machine Id
21-GB-6464 PORT MAIN ENGINE GEARBOX AND PITCH CONTROL (S/N Maint Plan 22463)
Component
1 Gearbox
Fluid
MOBIL MOBILGEAR 627 (1000 LTR)

Customer Id: SPESTJ
Sample No.: PP
Lab Number: 02592271
Test Package: IND 2

OIL ANALYSIS REPORT

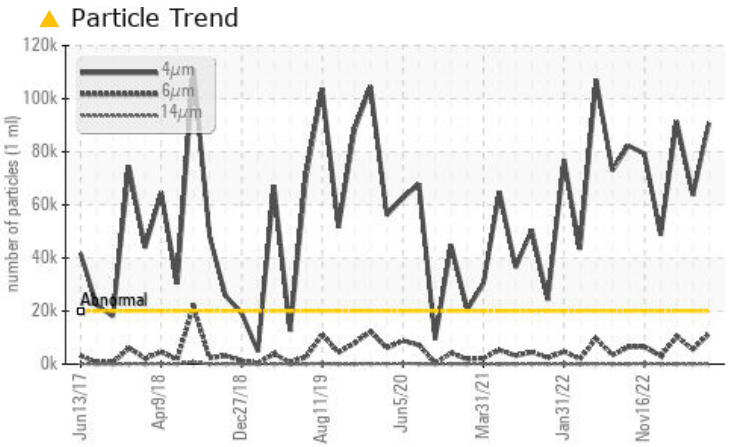
COMPONENT CONDITION SUMMARY

Sample Status				ABNORMAL	ABNORMAL	ABNORMAL
Particles >4µm		ASTM D7647	>20000	▲ **90836**	▲ 63685	▲ 91391
Particles >6µm		ASTM D7647	>5000	▲ **11471**	▲ 5588	▲ 10328
Oil Cleanliness		ISO 4406 (c)	>21/19/16	▲ **24/21/13**	▲ 23/20/12	▲ 24/21/12

We recommend you service the filters on this component. We recommend an early resample to monitor this condition.

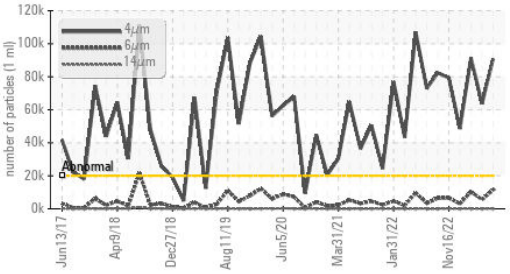
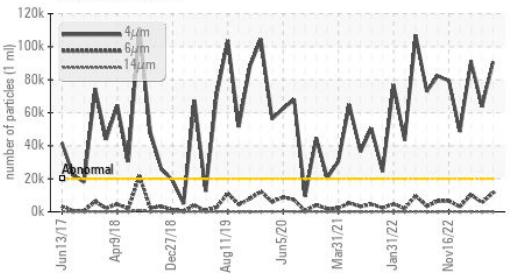
Particle Trend

There is a moderate amount of silt (particulates < 14 microns in size) present in the oil.

FLUID CLEANLINESS		method	limit/base	current	history1	history2
Particles >4µm		ASTM D7647	>20000	▲ **90836**	▲ 63685	▲ 91391
Particles >6µm		ASTM D7647	>5000	▲ **11471**	▲ 5588	▲ 10328
Particles >14µm		ASTM D7647	>640	**78**	21	40
Particles >21µm		ASTM D7647	>160	**18**	4	9
Particles >38µm		ASTM D7647	>40	**2**	0	0
Particles >71µm		ASTM D7647	>10	**1**	0	0
Oil Cleanliness		ISO 4406 (c)	>21/19/16	▲ **24/21/13**	▲ 23/20/12	▲ 24/21/12

We recommend you service the filters on this component. We recommend an early resample to monitor this condition.
