OIL ANALYSIS REPORT

Area
(C-GSNM) SKYNORTH AIR LTD
Machine Id
BEECHCRAFT PCE51100
Component
Left Jet Turbine
Fluid
EASTMAN TURBO OIL 2380 (--- GAL)

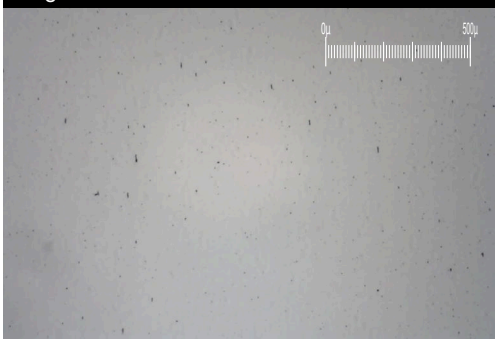
Magn: 50x Illum: RW

All component wear rates are normal. The ferrography results are normal indicating no abnormal wear in the system.
