PROBLEM SUMMARY

Area
BUILDING 51 - CEREAL PRODUCTS
Machine Id
ROTARY DRYER #3 GEARBOX (S/N 51D3-GB)
Component
Gearbox
Fluid
LUBRICATION ENG DUOLEC 1605 GEAR OIL 220 (120 LTR)

OIL ANALYSIS REPORT

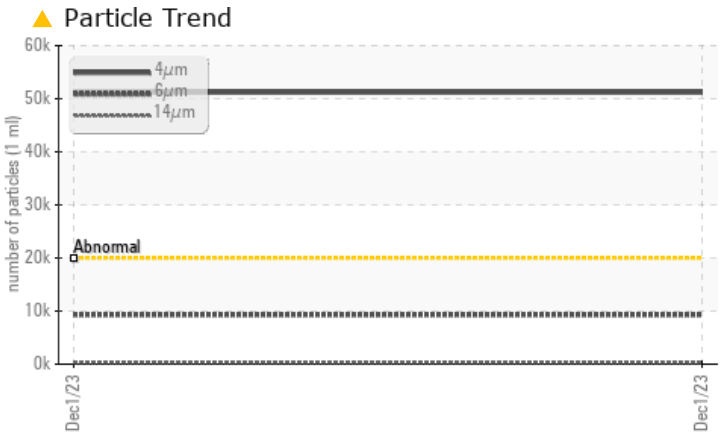
COMPONENT CONDITION SUMMARY

Sample Status				**ABNORMAL**	---	---
Particles >4µm		ASTM D7647	>20000	▲ **51179**	---	---
Particles >6µm		ASTM D7647	>5000	▲ **9294**	---	---
Oil Cleanliness		ISO 4406 (c)	>21/19/16	▲ **23/20/16**	---	---

Contamination
There is a moderate amount of silt (particulates < 14 microns in size) present in the oil.

We recommend you service the filters on this component. We recommend an early resample to monitor this condition.

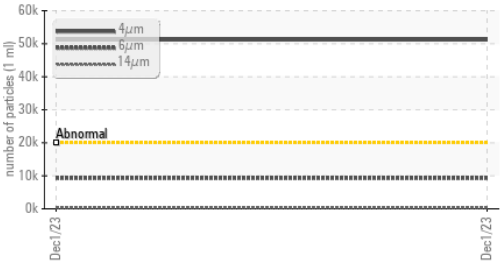
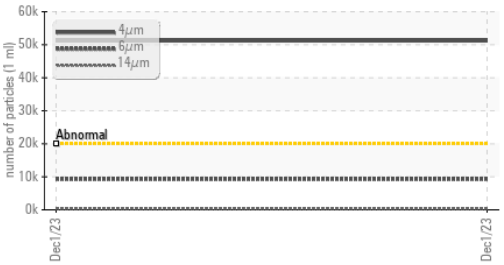
Particle Trend

FLUID CLEANLINESS		method	limit/base	current	history1	history2
Particles >4µm		ASTM D7647	>20000	▲ **51179**	---	---
Particles >6µm		ASTM D7647	>5000	▲ **9294**	---	---
Particles >14µm		ASTM D7647	>640	**328**	---	---
Particles >21µm		ASTM D7647	>160	**98**	---	---
Particles >38µm		ASTM D7647	>40	**13**	---	---
Particles >71µm		ASTM D7647	>10	**2**	---	---
Oil Cleanliness		ISO 4406 (c)	>21/19/16	▲ **23/20/16**	---	---

Recommendation
We recommend you service the filters on this component. We recommend an early resample to monitor this condition.
