OIL ANALYSIS REPORT

Machine Id
Water Injection Pool 4/5 (S/N CAHE-V684207)
Component
Gearbox
Fluid
MOBIL DTE OIL LIGHT (--- LTR)

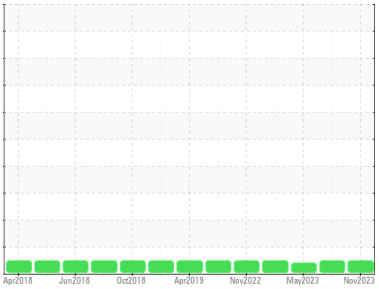
Sample Rating Trend

NORMAL

Fluid Condition
Additive levels indicate the addition of a different brand, or type of oil. The AN level is acceptable for this fluid. The condition of the oil is suitable for further service.

Recommendation
Confirm the source of the lubricant being utilized for top-up/fill. Resample at the next service interval to monitor. NOTE: Please provide information regarding reservoir capacity, filter type and micron rating with next sample.

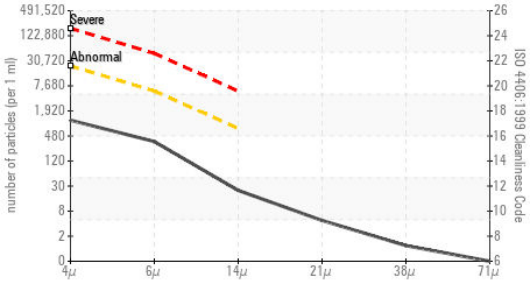
Particle Count

Contamination
The system cleanliness is acceptable for your target ISO 4406 cleanliness code. The system and fluid cleanliness is acceptable.

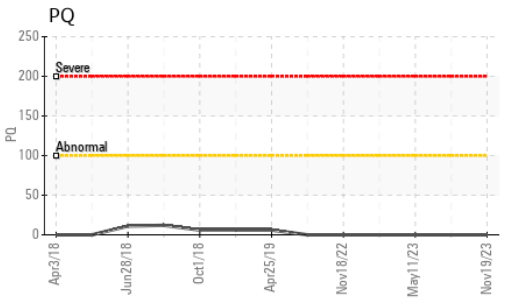
PQ

Wear
All component wear rates are normal.
