Customer Id: EXXSTJ
Sample No.: PP13931249
Lab Number: 02601547
Test Package: MAR 2

OIL ANALYSIS REPORT

Area
Water Injection
Machine Id
V684225 POOL 1 WATER INJECTION PUMP SKID #2
Component
Lube System
Fluid
MOBIL DTE OIL LIGHT (--- LTR)

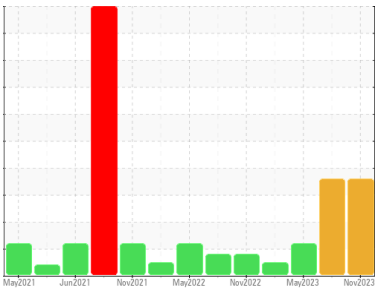
Sample Rating Trend

WATER

Sample Status				**ABNORMAL**	SEVERE	ABNORMAL
Particles >4µm		ASTM D7647	>5000	**16343**	102821	36550
Particles >6µm		ASTM D7647	>1300	**3543**	20876	3814
Oil Cleanliness		ISO 4406 (c)	>19/17/14	**21/19/13**	24/22/14	22/19/11
Appearance	scalar	Visual*	NORML	**WGOIL**	NORML	NORML
Free Water	scalar	Visual*		**5%**	NEG	NEG

We advise that you check for the source of water entry. Check seals and/or filters for points of contaminant entry. The air breather requires service. If unrated, we recommend that you replace with a suitable micron rated and/or desiccant air breather. If rated, we recommend that you service/replace the breather. We advise that you use off-line filtration with water adsorbent filters to attempt to remove the water from this oil. We advise that you follow the water drain-off procedure for this component. We recommend you service the filters on this component. We recommend an early resample to monitor this condition. NOTE: Please provide information regarding reservoir capacity, filter type and micron rating with next sample.

Action	Status	Date	Done By	Description
Change Filter	---	---	?	We recommend you service the filters on this component.
Water Drain-off	---	---	?	We advise that you follow the water drain-off procedure for this component.
Resample	---	---	?	We recommend an early resample to monitor this condition.
Information Required	---	---	?	NOTE: Please provide information regarding reservoir capacity, filter type and micron rating with next sample.
Check Breathers	---	---	?	The air breather requires service. If unrated, we recommend that you replace with a suitable micron rated and/or desiccant air breather. If rated, we recommend that you service/replace the breather.
Check Water Access	---	---	?	We advise that you check for the source of water entry.
Check Seals	---	---	?	Check seals and/or filters for points of contaminant entry.
Filter Fluid	---	---	?	We advise that you use off-line filtration with water adsorbent filters to attempt to remove the water from this oil.

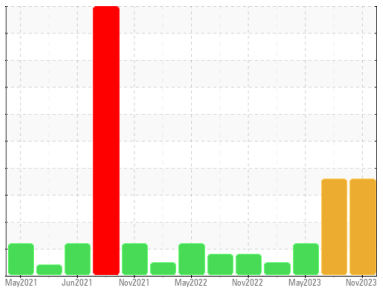
Sample Rating Trend

WATER

There is a moderate amount of silt (particulates < 14 microns in size) present in the oil. Free water present.

The AN level is acceptable for this fluid. The oil is still serviceable provided that the contaminant(s) can be reduced to acceptable levels.

We advise that you check for the source of water entry. Check seals and/or filters for points of contaminant entry. The air breather requires service. If unrated, we recommend that you replace with a suitable micron rated and/or desiccant air breather. If rated, we recommend that you service/replace the breather. We advise that you use off-line filtration with water adsorbent filters to attempt to remove the water from this oil. We advise that you follow the water drain-off procedure for this component. We recommend you service the filters on this component. We recommend an early resample to monitor this condition. NOTE: Please provide information regarding reservoir capacity, filter type and micron rating with next sample.

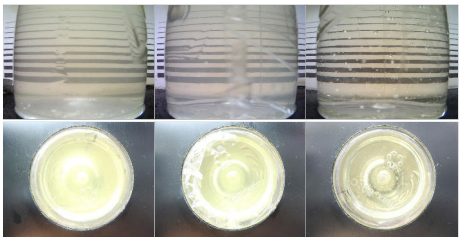
SAMPLE IMAGES	method	limit/base	current	history1	history2
Color					
Bottom

VISUAL		method	limit/base	current	history1	history2
White Metal	scalar	Visual*	NONE	**NONE**	NONE	NONE
Yellow Metal	scalar	Visual*	NONE	**NONE**	NONE	NONE
Precipitate	scalar	Visual*	NONE	**NONE**	NONE	NONE
Silt	scalar	Visual*	NONE	**NONE**	NONE	NONE
Debris	scalar	Visual*	NONE	**NONE**	NONE	NONE
Sand/Dirt	scalar	Visual*	NONE	**NONE**	NONE	NONE
Appearance	scalar	Visual*	NORML	▲ **WGOIL**	NORML	NORML
Odor	scalar	Visual*	NORML	**NORML**	NORML	NORML
Emulsified Water	scalar	Visual*	>0.05	**.2%**	NEG	NEG
Free Water	scalar	Visual*		▲ **5%**	NEG	NEG
