OIL ANALYSIS REPORT

Area
OLD P1 Line
Machine Id
PRESS 1
Component
Hydraulic System
Fluid
AW HYDRAULIC OIL ISO 46 (12000 LTR)

Laboratory : WearCheck - C8-1175 Appleby Line, Burlington, ON L7L 5H9
Sample No. : WC
Lab Number : 02601589
Unique Number : 5694674
Test Package : IND 2

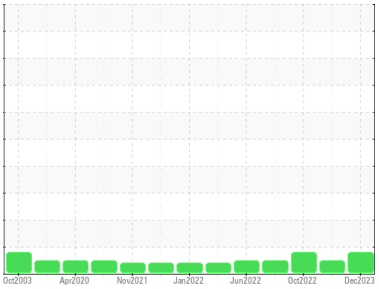
Sample Rating Trend

▲ Non-ferrous Metals

Sample Status				ABNORMAL	NORMAL	ATTENTION
Copper	ppm	ASTM D5185(m)	>20	▲ 17	2	9

We recommend an early resample to monitor this condition. Please specify the brand, type, and viscosity of the oil on your next sample. Please contact your representative for information regarding the proper sampling kits for your service. NOTE: We recommend using Advanced Oil Monitoring (AOM) kits for this system. The AOM test package includes advanced level testing to determine the suitability of turbine and large industrial compressor oils for continued use.

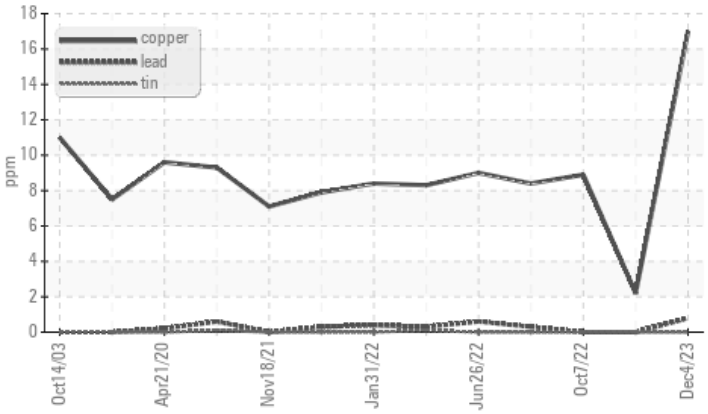
Copper ppm levels are abnormal. A sharp increase in the copper level is noted. Oil cooler core leaching or motor piston wear is indicated.
