PROBLEM SUMMARY

Area
IPEX - 888063
Machine Id
AM950
Component
Hydraulic System
Fluid
AW HYDRAULIC OIL ISO 46 (--- GAL)

OIL ANALYSIS REPORT

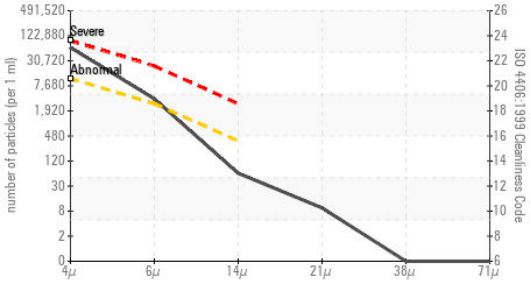
Particle Count

Contamination
Particles >4µm and oil cleanliness are abnormally high. Particles >6µm are notably high.

FLUID CLEANLINESS		method	limit/base	current	history1	history2
Particles >4µm		ASTM D7647	>10000	▲ **55137**	---	---
Particles >6µm		ASTM D7647	>2500	▲ **3265**	---	---
Particles >14µm		ASTM D7647	>320	**54**	---	---
Particles >21µm		ASTM D7647	>80	**8**	---	---
Particles >38µm		ASTM D7647	>20	**0**	---	---
Particles >71µm		ASTM D7647	>4	**0**	---	---
Oil Cleanliness		ISO 4406 (c)	>20/18/15	▲ **23/19/13**	---	---

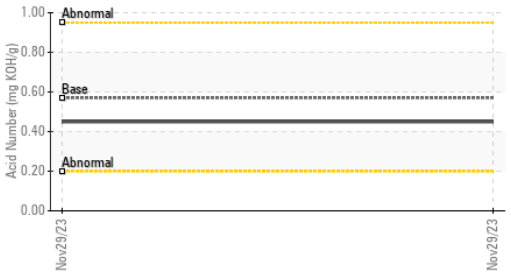
FLUID DEGRADATION		method	limit/base	current	history1	history2
Acid Number (AN)	mg KOH/g	ASTM D974*	0.57	**0.45**	---	---

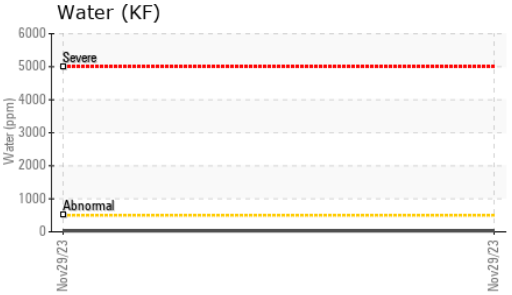
Water (KF)

CONTAMINANTS		method	limit/base	current	history1	history2
Silicon	ppm	ASTM D5185(m)	>15	**0**	---	---
Sodium	ppm	ASTM D5185(m)		**<1**	---	---
Potassium	ppm	ASTM D5185(m)	>20	**0**	---	---
Water	%	ASTM D6304*	>0.05	**0.003**	---	---
ppm Water	ppm	ASTM D6304*	>500	**30**	---	---
