Customer Id: CHECOB
Sample No.: E30000892
Lab Number: 02601833
Test Package: IND 2

OIL ANALYSIS REPORT

Area
IPEX - 888063
Machine Id
AM953
Component
Hydraulic System
Fluid
AW HYDRAULIC OIL ISO 46 (--- GAL)

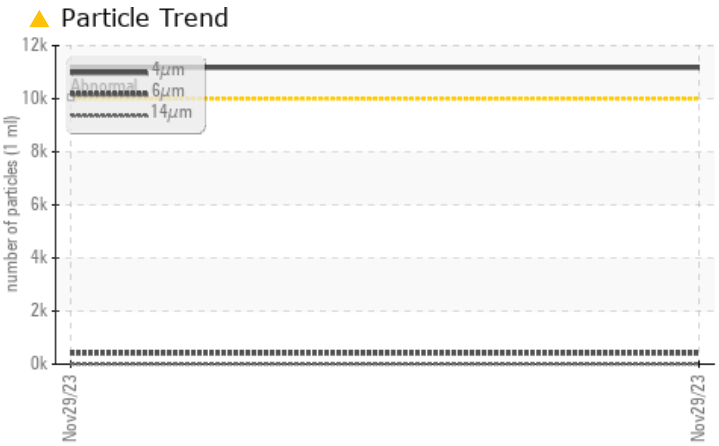
COMPONENT CONDITION SUMMARY

Sample Status				ATTENTION	---	---
Particles >4µm		ASTM D7647	>10000	▲ 11173	---	---
Oil Cleanliness		ISO 4406 (c)	>20/18/15	▲ 21/16/11	---	---

Contamination
Particles >4µm and oil cleanliness are notably high.

This is a baseline read-out on the submitted sample.

There are no recommended actions for this sample.

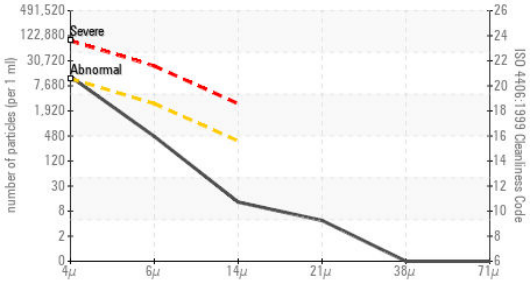
Particle Count

FLUID CLEANLINESS		method	limit/base	current	history1	history2
Particles >4µm		ASTM D7647	>10000	▲ **11173**	---	---
Particles >6µm		ASTM D7647	>2500	**412**	---	---
Particles >14µm		ASTM D7647	>320	**11**	---	---
Particles >21µm		ASTM D7647	>80	**4**	---	---
Particles >38µm		ASTM D7647	>20	**0**	---	---
Particles >71µm		ASTM D7647	>4	**0**	---	---
Oil Cleanliness		ISO 4406 (c)	>20/18/15	▲ **21/16/11**	---	---

Recommendation
This is a baseline read-out on the submitted sample.

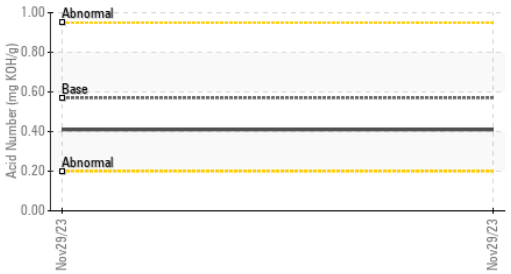
FLUID DEGRADATION		method	limit/base	current	history1	history2
Acid Number (AN)	mg KOH/g	ASTM D974*	0.57	**0.41**	---	---

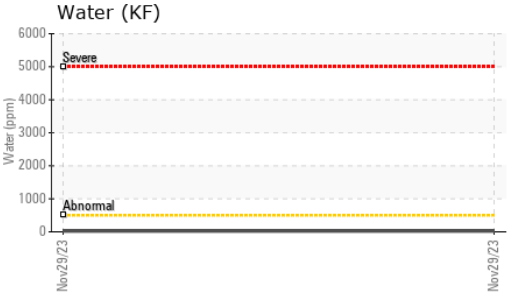
Water (KF)

CONTAMINANTS		method	limit/base	current	history1	history2
Silicon	ppm	ASTM D5185(m)	>15	**0**	---	---
Sodium	ppm	ASTM D5185(m)		**0**	---	---
Potassium	ppm	ASTM D5185(m)	>20	**<1**	---	---
Water	%	ASTM D6304*	>0.05	**0.002**	---	---
ppm Water	ppm	ASTM D6304*	>500	**23**	---	---
