PROBLEM SUMMARY

Area
IPEX - 888063
Machine Id
AM948
Component
Hydraulic System
Fluid
AW HYDRAULIC OIL ISO 46 (--- GAL)

OIL ANALYSIS REPORT

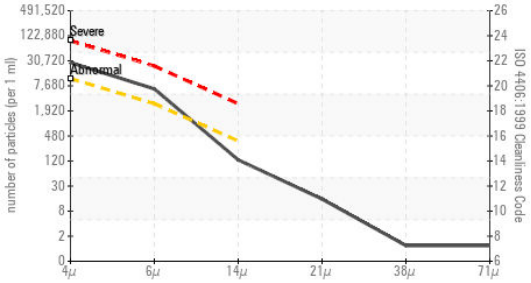
Particle Count

Contamination
Particles >4µm are abnormally high. Particles >6µm and oil cleanliness are abnormally high.
