PROBLEM SUMMARY

Area
OPF2/BD08
Machine Id
109550 KM Extruder
Component
Gearbox
Fluid
MOBIL MOBILGEAR 600 XP 320 (300 LTR)

Customer Id: MITWAT
Sample No.: WC0855098
Lab Number: 02601991
Test Package: IND 2

OIL ANALYSIS REPORT

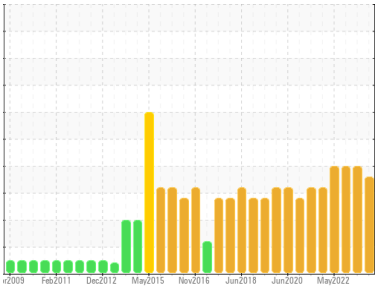
Sample Rating Trend

ISO

Sample Status				**SEVERE**	SEVERE	SEVERE
Particles >4µm		ASTM D7647	>20000	**187793**	331923	380865
Particles >6µm		ASTM D7647	>5000	**74271**	214611	217003
Oil Cleanliness		ISO 4406 (c)	>21/19/16	**25/23/16**	26/25/19	26/25/18

Check seals and/or filters for points of contaminant entry. The air breather requires service. If unrated, we recommend that you replace with a suitable micron rated and/or desiccant air breather. If rated, we recommend that you service/replace the breather. We recommend you service the filters on this component. Resample in 30-45 days to monitor this situation.

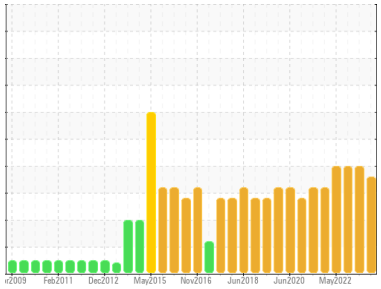
Sample Rating Trend

ISO

There is a high amount of silt (particulates < 14 microns in size) present in the oil.

The AN level is acceptable for this fluid. The oil is still serviceable provided that the contaminant(s) can be reduced to acceptable levels.

Check seals and/or filters for points of contaminant entry. The air breather requires service. If unrated, we recommend that you replace with a suitable micron rated and/or desiccant air breather. If rated, we recommend that you service/replace the breather. We recommend you service the filters on this component. Resample in 30-45 days to monitor this situation.
