Customer Id: HUSBOLED
Sample No.: WC0887627
Lab Number: 02602257
Test Package: IND 2

OIL ANALYSIS REPORT

Machine Id
KASTO SAW #10 (Saw Cut - NGOM) - cc4975
Component
Hydraulic System
Fluid
AW HYDRAULIC OIL ISO 15 (--- GAL)

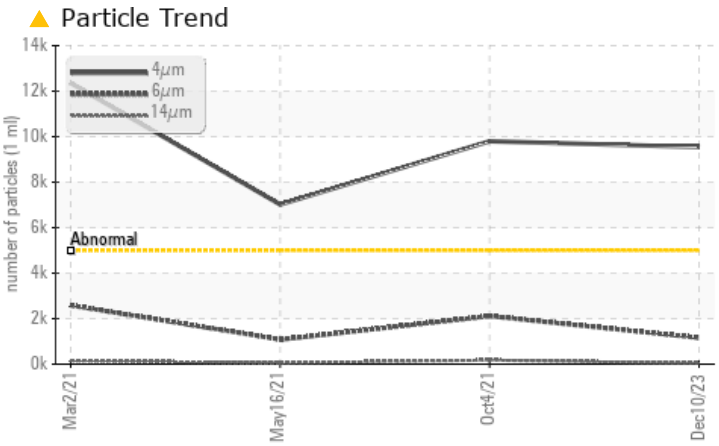
COMPONENT CONDITION SUMMARY

Sample Status				ATTENTION	ATTENTION	ATTENTION
Particles >4µm		ASTM D7647	>5000	▲ **9541**	▲ 9798	▲ 7017
Oil Cleanliness		ISO 4406 (c)	>19/17/14	▲ **20/17/12**	▲ 20/18/15	▲ 20/17/13

Little or no information is provided as to the component and lubricant being tested. Recommendations are therefore generic in nature and may not apply to the current application. Please forward information as to equipment type, reservoir capacity, lubricant type and any pertinent information to allow for a more accurate assessment. We recommend you service the filters on this component. Resample at the next service interval to monitor. The fluid was not specified, however, a fluid match indicates that this fluid is (GENERIC) AW HYDRAULIC OIL ISO 15. Please confirm.
NOTE: Please provide information regarding reservoir capacity, filter type and micron rating with next sample.

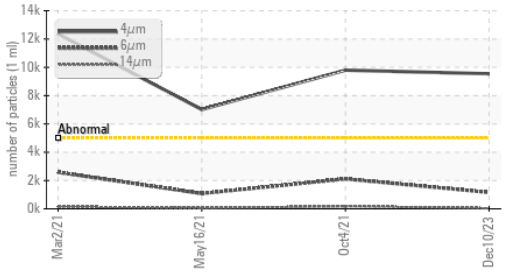
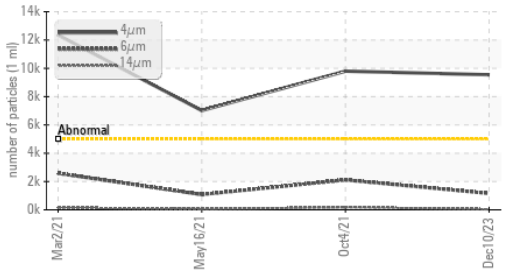
Particle Trend

There is a light amount of silt (particulates < 14 microns in size) present in the oil.

FLUID CLEANLINESS		method	limit/base	current	history1	history2
Particles >4µm		ASTM D7647	>5000	▲ **9541**	▲ 9798	▲ 7017
Particles >6µm		ASTM D7647	>1300	**1158**	▲ 2110	1081
Particles >14µm		ASTM D7647	>160	**33**	▲ 176	49
Particles >21µm		ASTM D7647	>40	**7**	43	7
Particles >38µm		ASTM D7647	>10	**2**	2	0
Particles >71µm		ASTM D7647	>3	**1**	0	0
Oil Cleanliness		ISO 4406 (c)	>19/17/14	▲ **20/17/12**	▲ 20/18/15	▲ 20/17/13

Action	Status	Date	Done By	Description
Change Filter	---	---	?	We recommend you service the filters on this component.
Alert	---	---	?	Little or no information is provided as to the component and lubricant being tested. Recommendations are therefore generic in nature and may not apply to the current application. Please forward information as to equipment type, reservoir capacity, lubricant type and any pertinent information to allow for a more accurate assessment.
Information Required	---	---	?	NOTE: Please provide information regarding reservoir capacity, filter type and micron rating with next sample.

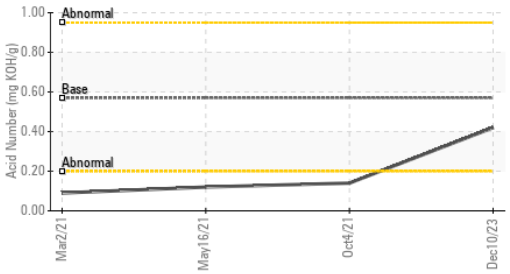
The AN level is acceptable for this fluid. The condition of the oil is suitable for further service.

FLUID DEGRADATION		method	limit/base	current	history1	history2
Acid Number (AN)	mg KOH/g	ASTM D974*	0.57	**0.42**	0.14	0.12

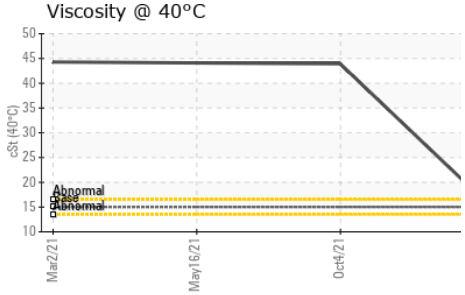
Viscosity @ 40°C

FLUID PROPERTIES		method	limit/base	current	history1	history2
Visc @ 40°C	cSt	ASTM D7279(m)	15	**16.3**	43.9	44.1

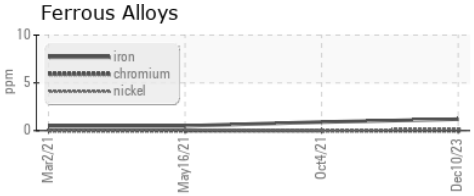
Ferrous Alloys

All component wear rates are normal.

WEAR METALS		method	limit/base	current	history1	history2
Iron	ppm	ASTM D5185(m)	>20	**1**	<1	<1
Chromium	ppm	ASTM D5185(m)	>20	**0**	0	0
Nickel	ppm	ASTM D5185(m)	>20	**<1**	0	<1
Titanium	ppm	ASTM D5185(m)		**0**	0	0
Silver	ppm	ASTM D5185(m)		**<1**	<1	<1
Aluminum	ppm	ASTM D5185(m)	>20	**0**	0	<1
Lead	ppm	ASTM D5185(m)	>20	**<1**	0	<1
Copper	ppm	ASTM D5185(m)	>20	**2**	<1	<1
Tin	ppm	ASTM D5185(m)	>20	**0**	<1	0
Antimony	ppm	ASTM D5185(m)		**0**	0	0
Vanadium	ppm	ASTM D5185(m)		**0**	0	0
Beryllium	ppm	ASTM D5185(m)		**0**	0	0
Cadmium	ppm	ASTM D5185(m)		**0**	0	0
