Machine Id
Behringer Horizontal Band Saw # 012 - cc4030
Component
Hydraulic System
Fluid
AW HYDRAULIC OIL ISO 46 (--- GAL)

Customer Id: HUSBOLED
Sample No.: WC0888621
Lab Number: 02602281
Test Package: IND 2

OIL ANALYSIS REPORT

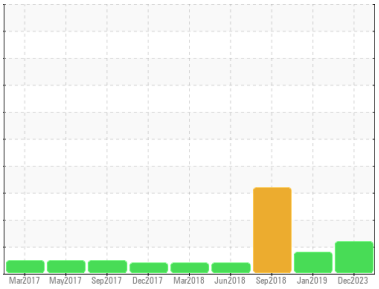
Sample Rating Trend

Sample Status				**ABNORMAL**	ABNORMAL	SEVERE
Particles >4µm		ASTM D7647	>5000	▲ **5310**	▲ 6532	⬢ 71135
Oil Cleanliness		ISO 4406 (c)	>19/17/14	▲ **20/17/12**	▲ 20/17/13	⬢ 23/21/14
Visc @ 40°C	cSt	ASTM D7279(m)	46	▲ **30.9**	▲ 33.3	▲ 33.4

Action	Status	Date	Done By	Description
Change Filter	---	---	?	We recommend you service the filters on this component.
Alert	---	---	?	Little or no information is provided as to the component and lubricant being tested. Recommendations are therefore generic in nature and may not apply to the current application. Please forward information as to equipment type, reservoir capacity, lubricant type and any pertinent information to allow for a more accurate assessment.
Information Required	---	---	?	Please specify the brand, type, and viscosity of the oil on your next sample. NOTE: Please provide information regarding reservoir capacity, filter type and micron rating with next sample.

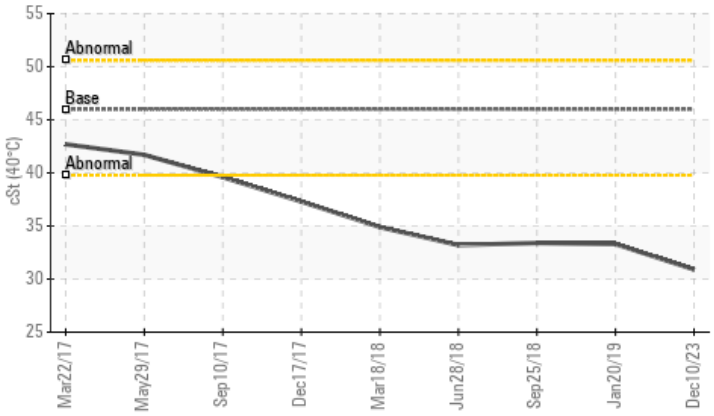
Viscosity @ 40°C

Viscosity of sample indicates oil is within ISO 32 range, advise investigate. The AN level is acceptable for this fluid. The condition of the oil is suitable for further service.

FLUID PROPERTIES		method	limit/base	current	history1	history2
Visc @ 40°C	cSt	ASTM D7279(m)	46	▲ **30.9**	▲ 33.3	▲ 33.4

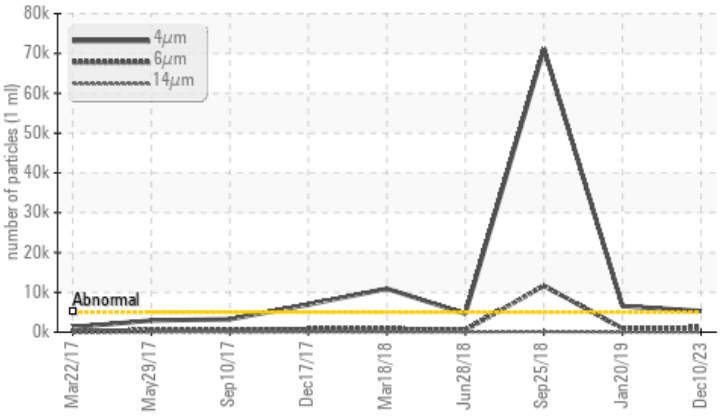
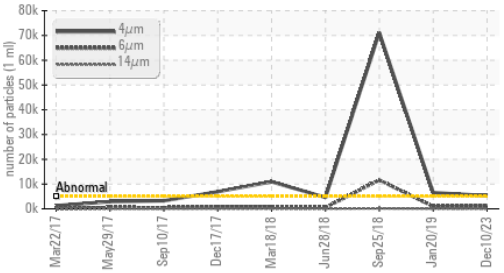
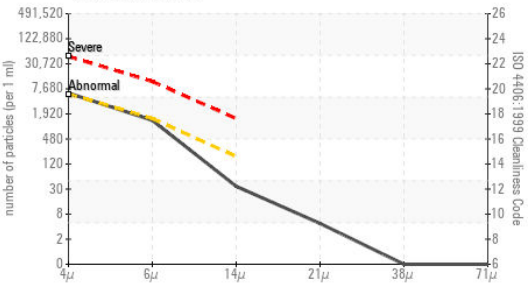
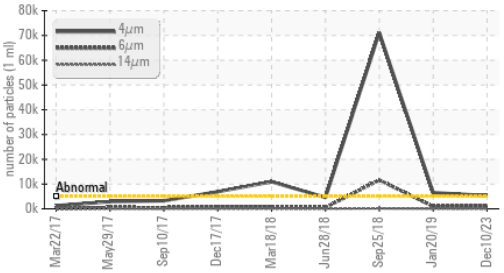
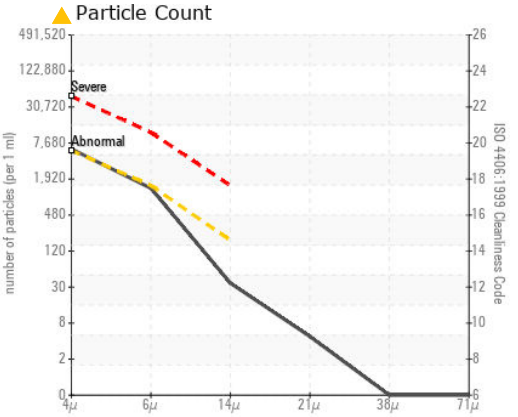
Particle Trend

There is a light amount of silt (particulates < 14 microns in size) present in the oil.

FLUID CLEANLINESS		method	limit/base	current	history1	history2
Particles >4µm		ASTM D7647	>5000	▲ **5310**	▲ 6532	⬢ 71135
Particles >6µm		ASTM D7647	>1300	**1180**	942	⬢ 11631
Particles >14µm		ASTM D7647	>160	**31**	41	145
Particles >21µm		ASTM D7647	>40	**4**	9	25
Particles >38µm		ASTM D7647	>10	**0**	0	0
Particles >71µm		ASTM D7647	>3	**0**	0	0
Oil Cleanliness		ISO 4406 (c)	>19/17/14	▲ **20/17/12**	▲ 20/17/13	⬢ 23/21/14

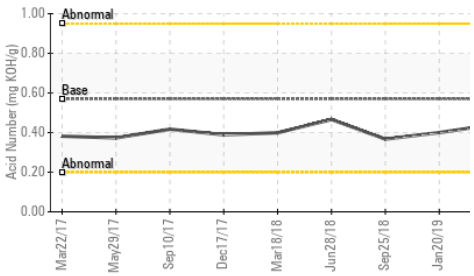
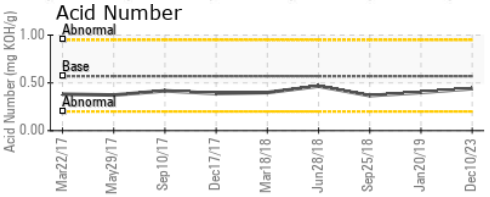
FLUID DEGRADATION		method	limit/base	current	history1	history2
Acid Number (AN)	mg KOH/g	ASTM D974*	0.57	**0.44**	0.40	0.367
