Customer Id: GOONAP
Sample No.: WC0873617
Lab Number: 02602299
Test Package: IND 2

OIL ANALYSIS REPORT

Area
TC02
Machine Id
TC02
Component
Hydraulic System
Fluid
TRIBOL HYDRAULIC 943AW-68 (--- LTR)

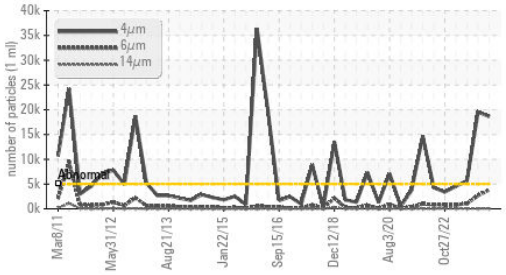
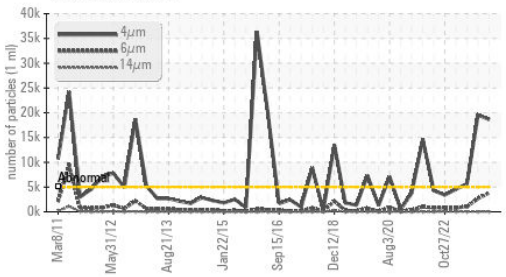
Particle Trend

There is a moderate amount of silt (particulates < 14 microns in size) present in the oil.

FLUID CLEANLINESS		method	limit/base	current	history1	history2
Particles >4µm		ASTM D7647	>5000	▲ **18641**	▲ 19557	▲ 5668
Particles >6µm		ASTM D7647	>1300	▲ **3837**	▲ 2657	1055
Particles >14µm		ASTM D7647	>160	**62**	62	57
Particles >21µm		ASTM D7647	>40	**6**	17	13
Particles >38µm		ASTM D7647	>10	**1**	1	1
Particles >71µm		ASTM D7647	>3	**0**	0	0
Oil Cleanliness		ISO 4406 (c)	>19/17/14	▲ **21/19/13**	▲ 21/19/13	▲ 20/17/13

We recommend you service the filters on this component. We recommend an early resample to monitor this condition. NOTE: Please provide information regarding reservoir capacity, filter type and micron rating with next sample.
