Customer Id: GOONAP
Sample No.: WC0873614
Lab Number: 02602417
Test Package: IND 2

OIL ANALYSIS REPORT

Area
TC01
Machine Id
TC01 4.5 Inch
Component
Gearbox
Fluid
SHELL OMALA S2 G 320 (40 GAL)

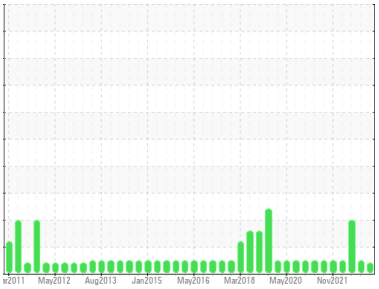
Sample Rating Trend

VISCOSITY

Sample Status				**ABNORMAL**	NORMAL	ABNORMAL
Visc @ 40°C	cSt	ASTM D7279(m)	320	▲ **235**	232	▲ 313

Resample at the next service interval to monitor.

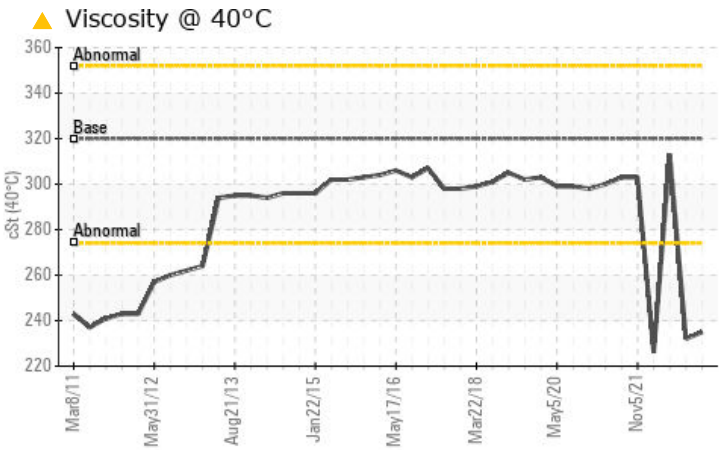
COMPONENT CONDITION SUMMARY

Fluid Condition
Viscosity of sample indicates oil is within ISO 220 range, advise investigate. The AN level is acceptable for this fluid. The condition of the oil is suitable for further service.

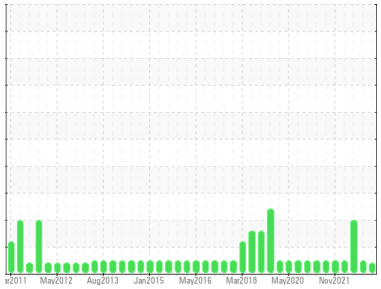
Sample Rating Trend

VISCOSITY

Recommendation
Resample at the next service interval to monitor.

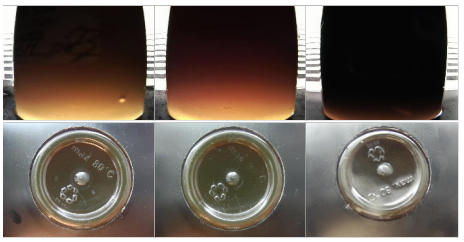
SAMPLE IMAGES	method	limit/base	current	history1	history2
Color					
Bottom

VISUAL		method	limit/base	current	history1	history2
White Metal	scalar	Visual*	NONE	**NONE**	NONE	NONE
Yellow Metal	scalar	Visual*	NONE	**NONE**	NONE	NONE
Precipitate	scalar	Visual*	NONE	**NONE**	NONE	NONE
Silt	scalar	Visual*	NONE	**NONE**	NONE	NONE
Debris	scalar	Visual*	NONE	**NONE**	VLITE	NONE
Sand/Dirt	scalar	Visual*	NONE	**NONE**	NONE	NONE
Appearance	scalar	Visual*	NORML	**NORML**	NORML	NORML
Odor	scalar	Visual*	NORML	**NORML**	NORML	NORML
Emulsified Water	scalar	Visual*	>0.2	**NEG**	NEG	NEG
Free Water	scalar	Visual*		**NEG**	NEG	NEG
