Machine Id
PRESS HYD TANK #2
Component
Hydraulic System
Fluid
AW HYDRAULIC OIL ISO 68 (--- GAL)

Customer Id: MACPEM
Sample No.: WC0855146
Lab Number: 02602628
Test Package: IND 2

OIL ANALYSIS REPORT

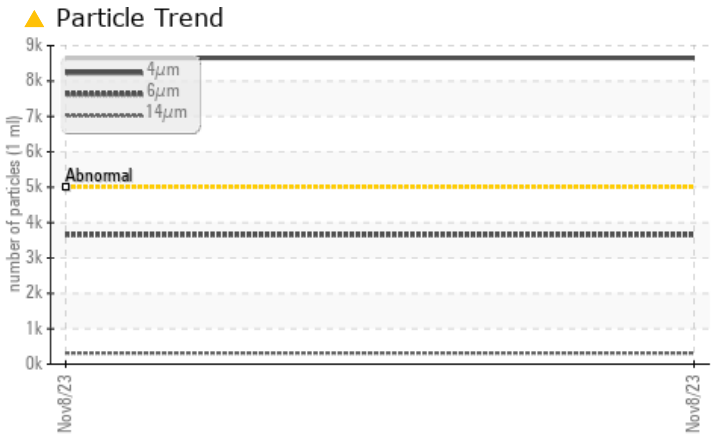
COMPONENT CONDITION SUMMARY

Sample Status				**ABNORMAL**	---	---
Particles >4µm		ASTM D7647	>5000	▲ **8653**	---	---
Particles >6µm		ASTM D7647	>1300	▲ **3656**	---	---
Particles >14µm		ASTM D7647	>160	▲ **312**	---	---
Particles >21µm		ASTM D7647	>40	▲ **65**	---	---
Oil Cleanliness		ISO 4406 (c)	>19/17/14	▲ **20/19/15**	---	---

There is a moderate amount of silt (particulates < 14 microns in size) present in the oil.

Action	Status	Date	Done By	Description
Change Filter	---	---	?	We recommend you service the filters on this component.
Resample	---	---	?	We recommend an early resample to monitor this condition.
Alert	---	---	?	Little or no information is provided as to the component and lubricant being tested. Recommendations are therefore generic in nature and may not apply to the current application. Please forward information as to equipment type, reservoir capacity, lubricant type and any pertinent information to allow for a more accurate assessment.
Information Required	---	---	?	Please specify the brand, type, and viscosity of the oil on your next sample. NOTE: Please provide information regarding reservoir capacity, filter type and micron rating with next sample.
