PROBLEM SUMMARY

Area
MGM 825 Coxwell #3 [4500057327]
Machine Id
CARRIER 0607Q73675
Component
Chiller
Fluid
ICI EMKARATE RL 68H (--- GAL)

OIL ANALYSIS REPORT

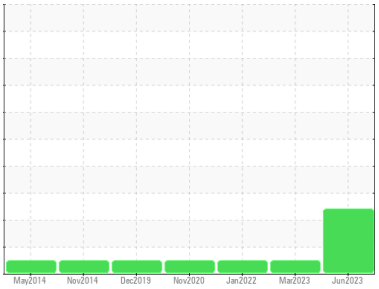
Sample Rating Trend

WATER

Sample Status				**ABNORMAL**	NORMAL	NORMAL
Tin	ppm	ASTM D5185(m)	>4	▲ **3**	<1	<1
ppm Water	ppm	ASTM D6304*	>100	▲ **227**	55	58

Recommend replacement of any filter driers because of the increased moisture level. We recommend an early resample to monitor this condition.

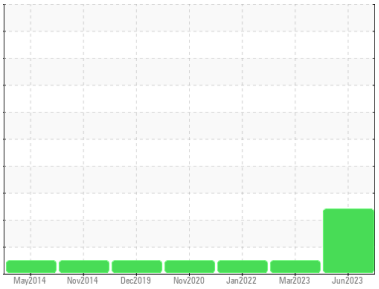
Sample Rating Trend

WATER

Wear
Tin ppm levels are abnormal. The tin reading shows moderate wear occurring on the compressor bearings or motor bearings.

Contamination
There is a moderate concentration of water present in the oil.

Recommendation
Recommend replacement of any filter driers because of the increased moisture level. We recommend an early resample to monitor this condition.
