Sample Rating Trend

Area
Engine room
Machine Id
G5-2111 Main Engine #1 (S/N C481)
Component
1 Main Engine
Fluid
SHELL ROTELLA T 30 (810 LTR)

OIL ANALYSIS REPORT

FERROGRAPHY REPORT

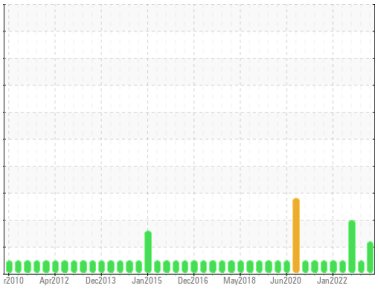
COOLANT

Sample Status				ATTENTION	NORMAL	ABNORMAL
Sodium	ppm	ASTM D5185(m)	>75	▲ 21	8	▲ 26

We recommend an early resample to monitor this condition.

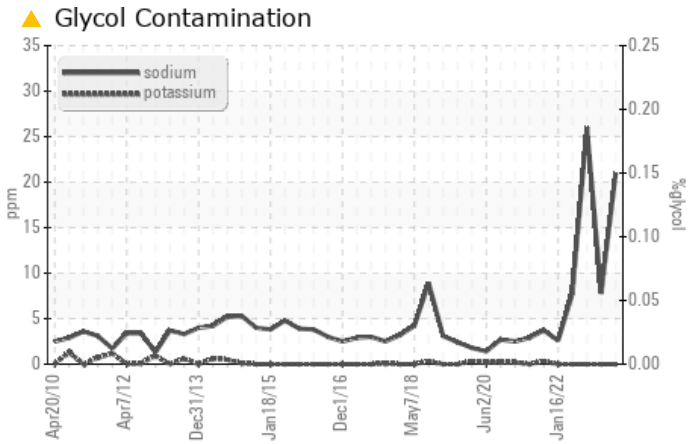
COMPONENT CONDITION SUMMARY

Water treatment chemicals present, indicating slow coolant leak. There is no indication of any contamination in the oil.

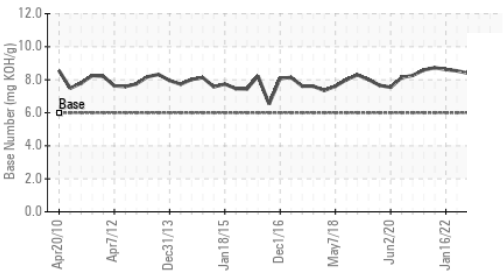
Base Number

The BN result indicates that there is suitable alkalinity remaining in the oil. The condition of the oil is suitable for further service.

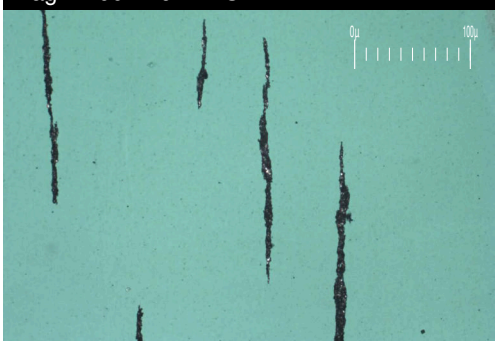
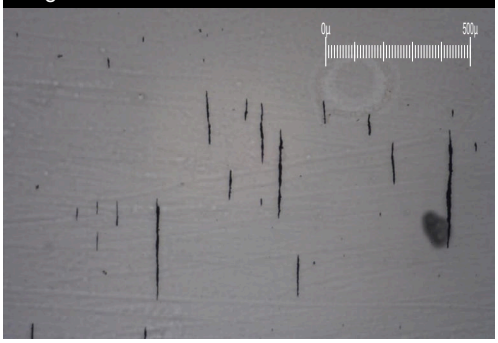
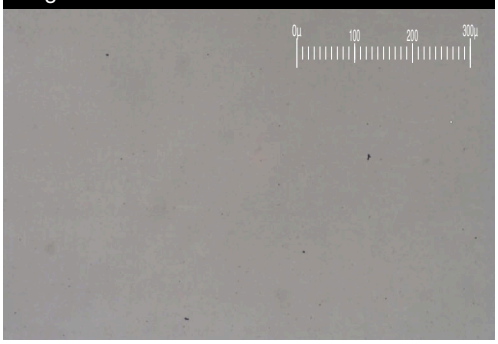
The ferrography results are normal indicating no abnormal wear in the system.
