OIL ANALYSIS REPORT

Machine Id
HONDA 2HKRS6H96PH200059
Component
Gasoline Engine
Fluid
PETRO CANADA SUPREME SYNTHETIC 0W20 (--- GAL)

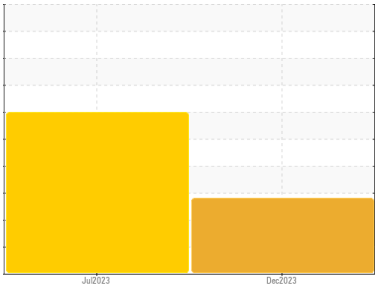
Sample Rating Trend

DIRT

Contamination
There is a moderate amount of fuel present in the oil. There is a moderate concentration of dirt present in the oil. Tests confirm the presence of fuel in the oil.

Recommendation
We advise that you check the air filter, air induction system, and any areas where dirt may enter the component. We recommend that you drain the oil from the component if this has not already been done. We recommend you service the filters on this component. We recommend an early resample to monitor this condition.

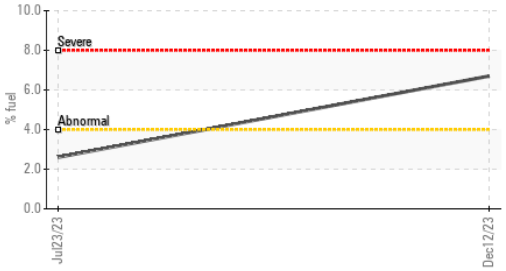
Fuel Dilution

CONTAMINANTS		method	limit/base	current	history1	history2
Silicon	ppm	ASTM D5185(m)	>30	▲ **55**	⬢ 217	---
Sodium	ppm	ASTM D5185(m)	>400	**2**	6	---
Potassium	ppm	ASTM D5185(m)	>20	**5**	10	---
Fuel	%	ASTM D7593*	>4.0	▲ **6.7**	▲ 2.6	---

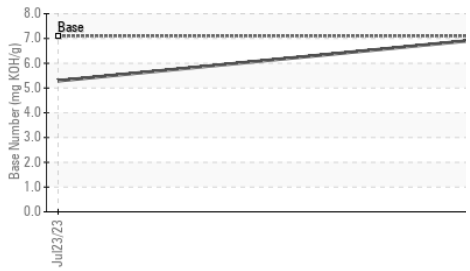
Base Number

Fluid Condition
The BN result indicates that there is suitable alkalinity remaining in the oil. Fuel is present in the oil and is lowering the viscosity. The oil is no longer serviceable due to the presence of contaminants.

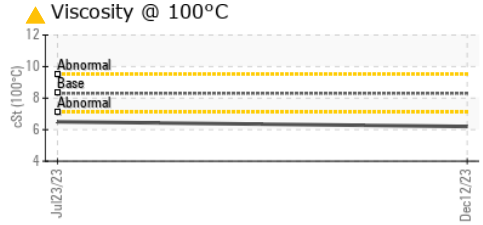
Viscosity @ 100°C

FLUID PROPERTIES		method	limit/base	current	history1	history2
Visc @ 100°C	cSt	ASTM D7279(m)	8.3	▲ **6.2**	▲ 6.5	---
