OIL ANALYSIS REPORT

Area
(C-GQSN)
Machine Id
[C-GQSN] BEECHCRAFT KING AIR 100 PCE-RB0123
Component
Left Jet Turbine
Fluid
EASTMAN TURBO OIL 2380 (--- LTR)

FERROGRAPHY REPORT

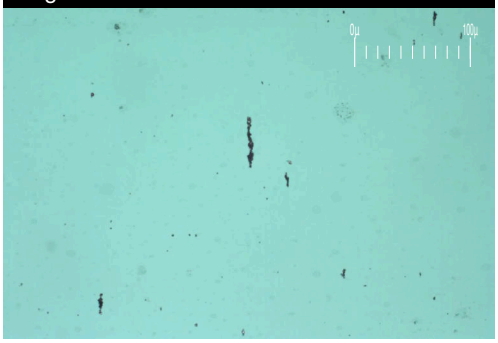
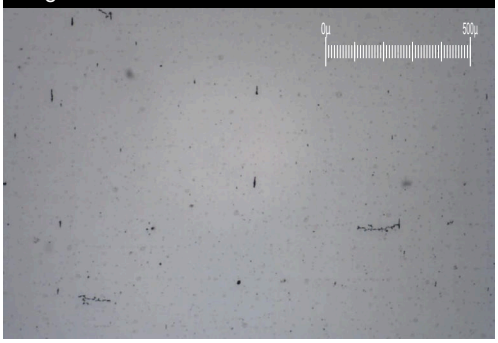
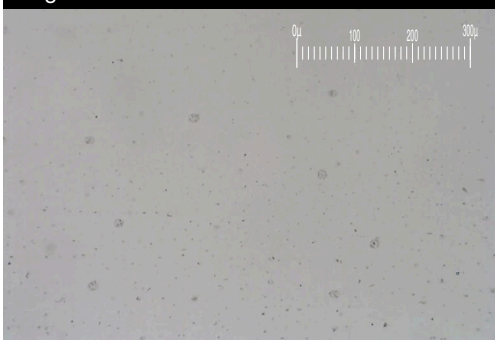
All component wear rates are normal. The ferrography results are normal indicating no abnormal wear in the system.
