Customer Id: NALGRA
Sample No.: WC0524888
Lab Number: 02603219
Test Package: IND 2

OIL ANALYSIS REPORT

Machine Id
GFP2 - UNIT 4 GOVERNOR (S/N 720060)
Component
Governor System
Fluid
SHELL TURBO T ISO 46 (4100 LTR)

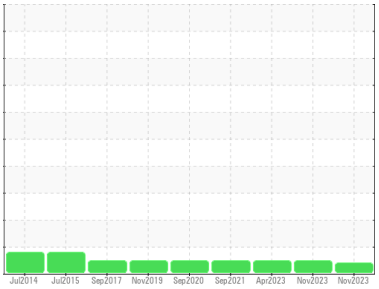
Sample Rating Trend

VISCOSITY

Sample Status				**ABNORMAL**	NORMAL	NORMAL
Visc @ 40°C	cSt	ASTM D7279(m)	46	▲ **66.0**	46.0	45.8

Resample at the next service interval to monitor. Please contact your representative for information regarding the proper sampling kits for your service. NOTE: We recommend using IND 3 test kits, this testkit includes Analytical Ferrography which provides a detailed morphological analysis of wear particles present in the fluid. (Customer Sample Comment: Unsure date)

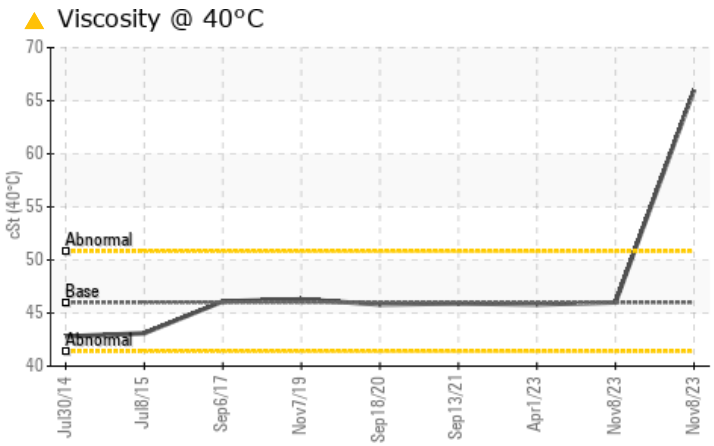
COMPONENT CONDITION SUMMARY

Viscosity of sample indicates oil is within ISO 68 range, advise investigate. The AN level is acceptable for this fluid. The condition of the oil is suitable for further service.

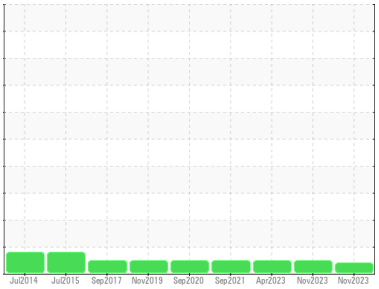
Sample Rating Trend

VISCOSITY

Resample at the next service interval to monitor. Please contact your representative for information regarding the proper sampling kits for your service. NOTE: We recommend using IND 3 test kits, this testkit includes Analytical Ferrography which provides a detailed morphological analysis of wear particles present in the fluid. (Customer Sample Comment: Unsure date)
