Customer Id: PETMIS
Sample No.: WC0883393
Lab Number: 02603333
Test Package: IND 2

OIL ANALYSIS REPORT

Area
2 Phoenix/020 ISO Dewax/P Pump/100A Feed Pump
Machine Id
N/A 20P100A (West)
Component
Pump
Fluid
PETRO CANADA TURBOFLO 32 (136 LTR)

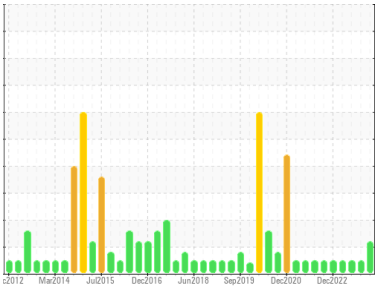
Sample Rating Trend

Sample Status				ABNORMAL	NORMAL	NORMAL
Particles >4µm		ASTM D7647	>5000	▲ **12975**	4377	3003
Particles >6µm		ASTM D7647	>1300	▲ **2550**	1225	1099
Oil Cleanliness		ISO 4406 (c)	>19/17/14	▲ **21/19/13**	19/17/13	19/17/14

We recommend you service the filters on this component. We recommend an early resample to monitor this condition.

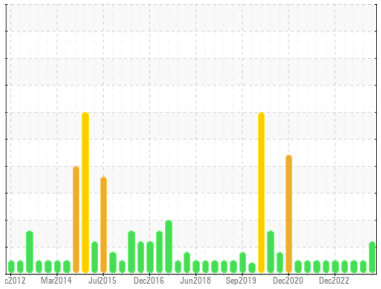
Sample Rating Trend

Contamination
There is a moderate amount of silt (particulates < 14 microns in size) present in the oil.

Fluid Condition
The AN level is acceptable for this fluid. The oil is still serviceable provided that the contaminant(s) can be reduced to acceptable levels.

Recommendation
We recommend you service the filters on this component. We recommend an early resample to monitor this condition.

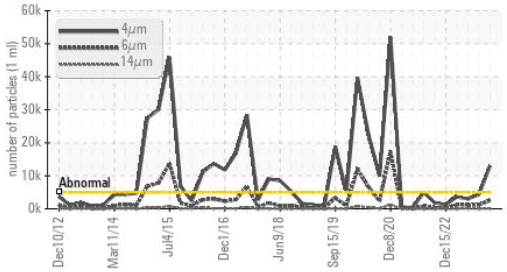
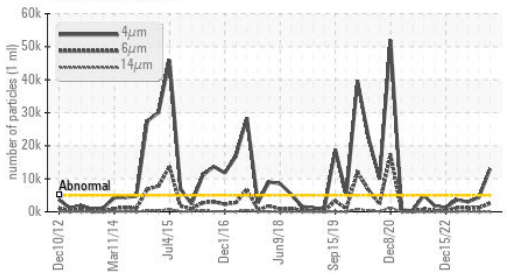
Particle Trend

FLUID CLEANLINESS		method	limit/base	current	history1	history2
Particles >4µm		ASTM D7647	>5000	▲ **12975**	4377	3003
Particles >6µm		ASTM D7647	>1300	▲ **2550**	1225	1099
Particles >14µm		ASTM D7647	>160	**76**	52	134
Particles >21µm		ASTM D7647	>40	**12**	10	27
Particles >38µm		ASTM D7647	>10	**1**	1	1
Particles >71µm		ASTM D7647	>3	**1**	0	0
Oil Cleanliness		ISO 4406 (c)	>19/17/14	▲ **21/19/13**	19/17/13	19/17/14

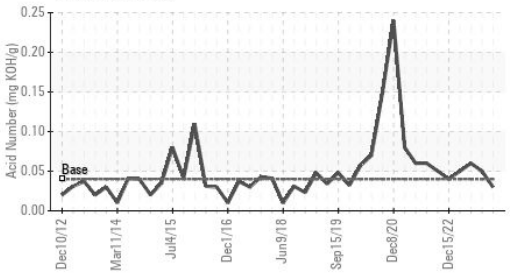
FLUID DEGRADATION		method	limit/base	current	history1	history2
Acid Number (AN)	mg KOH/g	ASTM D974*	0.04	**0.03**	0.05	0.06

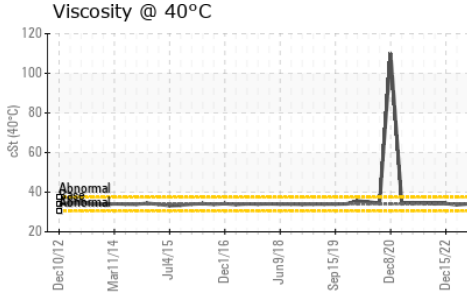
Viscosity @ 40°C

FLUID PROPERTIES		method	limit/base	current	history1	history2
Visc @ 40°C	cSt	ASTM D7279(m)	34.0	**34.4**	34.0	34.1

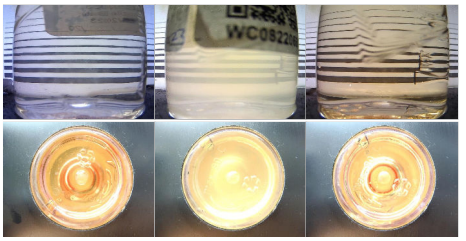
SAMPLE IMAGES	method	limit/base	current	history1	history2
Color					
Bottom

VISUAL		method	limit/base	current	history1	history2
White Metal	scalar	Visual*	NONE	**NONE**	NONE	NONE
Yellow Metal	scalar	Visual*	NONE	**NONE**	NONE	NONE
Precipitate	scalar	Visual*	NONE	**NONE**	NONE	NONE
Silt	scalar	Visual*	NONE	**NONE**	NONE	NONE
Debris	scalar	Visual*	NONE	**NONE**	NONE	NONE
Sand/Dirt	scalar	Visual*	NONE	**NONE**	NONE	NONE
Appearance	scalar	Visual*	NORML	**NORML**	NORML	NORML
Odor	scalar	Visual*	NORML	**NORML**	NORML	NORML
Emulsified Water	scalar	Visual*	>.1	**NEG**	NEG	NEG
Free Water	scalar	Visual*		**NEG**	NEG	NEG
