Customer Id: CHECOB
Sample No.: E30000923
Lab Number: 02603487
Test Package: IND 2

OIL ANALYSIS REPORT

Area
CORE MOLDING - C16700
Machine Id
M13348
Component
Hydraulic System
Fluid
NOT GIVEN (--- GAL)

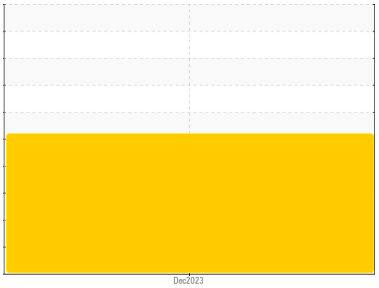
Sample Rating Trend

WATER

Sample Status				**ABNORMAL**	---	---
Water	%	ASTM D6304*	>0.05	▲ **0.168**	---	---
ppm Water	ppm	ASTM D6304*	>500	▲ **1689**	---	---
Particles >4µm		ASTM D7647	>10000	▲ **142123**	---	---
Particles >6µm		ASTM D7647	>2500	▲ **48661**	---	---
Particles >14µm		ASTM D7647	>320	▲ **2407**	---	---
Particles >21µm		ASTM D7647	>80	▲ **411**	---	---
Oil Cleanliness		ISO 4406 (c)	>20/18/15	▲ **24/23/18**	---	---
Free Water	scalar	Visual*		▲ **1%**	---	---

This is a baseline read-out on the submitted sample.

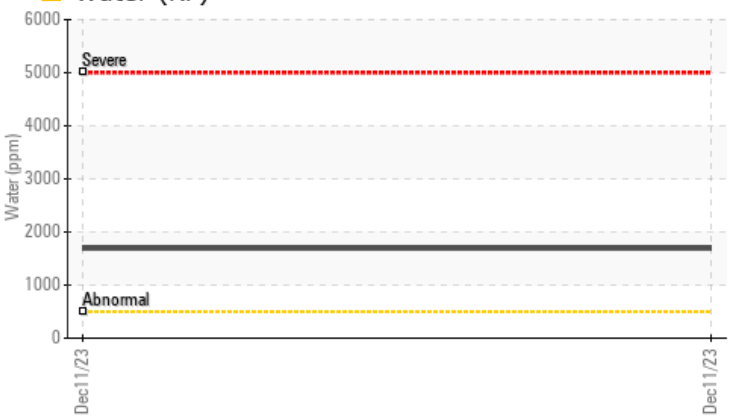
Water (KF)

Contamination
ppm Water and water contamination levels are abnormal. Particles >4µm are abnormally high. Particles >6µm are abnormally high. Oil Cleanliness are abnormally high. Particles >14µm are abnormally high. Particles >21µm are abnormally high. Silicon ppm levels are notably high.

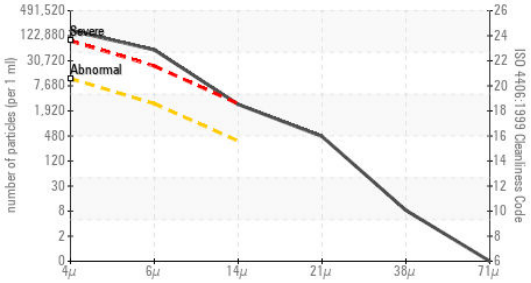
Particle Count

FLUID CLEANLINESS		method	limit/base	current	history1	history2
Particles >4µm		ASTM D7647	>10000	▲ **142123**	---	---
Particles >6µm		ASTM D7647	>2500	▲ **48661**	---	---
Particles >14µm		ASTM D7647	>320	▲ **2407**	---	---
Particles >21µm		ASTM D7647	>80	▲ **411**	---	---
Particles >38µm		ASTM D7647	>20	**7**	---	---
Particles >71µm		ASTM D7647	>4	**0**	---	---
Oil Cleanliness		ISO 4406 (c)	>20/18/15	▲ **24/23/18**	---	---

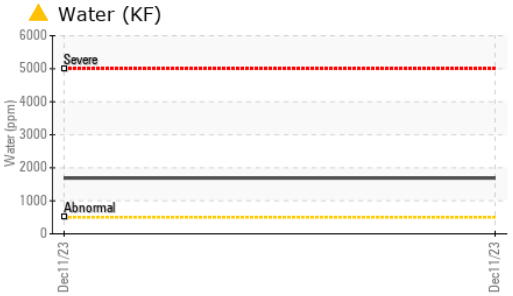
Water (KF)

CONTAMINANTS		method	limit/base	current	history1	history2
Silicon	ppm	ASTM D5185(m)	>15	**11**	---	---
Sodium	ppm	ASTM D5185(m)		**<1**	---	---
Potassium	ppm	ASTM D5185(m)	>20	**<1**	---	---
Water	%	ASTM D6304*	>0.05	▲ **0.168**	---	---
ppm Water	ppm	ASTM D6304*	>500	▲ **1689**	---	---

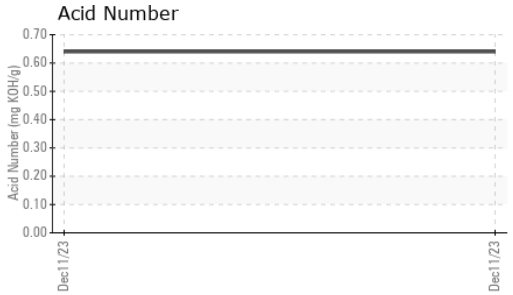
FLUID DEGRADATION		method	limit/base	current	history1	history2
Acid Number (AN)	mg KOH/g	ASTM D974*		**0.64**	---	---
