Customer Id: CLESPR
Sample No.: WC0782181
Lab Number: 02603791
Test Package: IND 2

OIL ANALYSIS REPORT

Machine Id
POWER PACK #1 LINE #1 (WOODGRAINER)
Component
Hydraulic System
Fluid
NOT GIVEN (--- GAL)

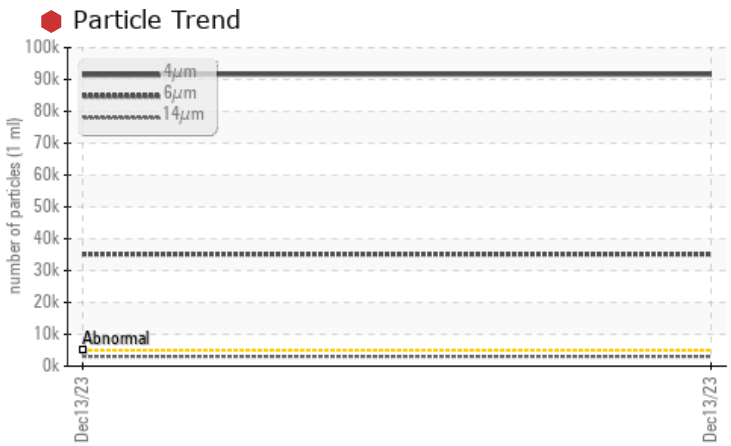
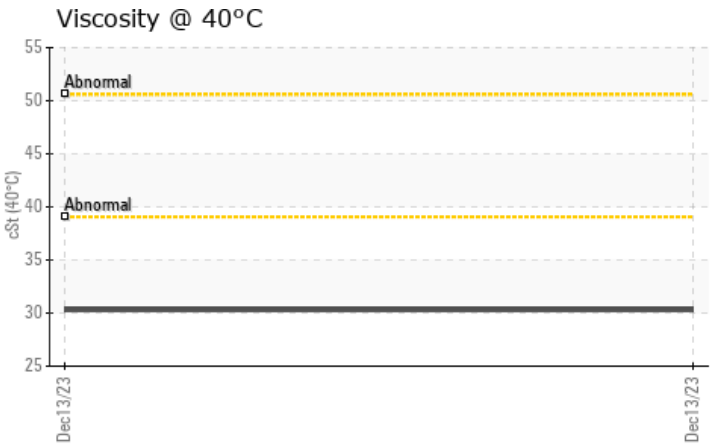
COMPONENT CONDITION SUMMARY

Sample Status				**SEVERE**	---	---
Particles >4µm		ASTM D7647	>5000	**91643**	---	---
Particles >6µm		ASTM D7647	>1300	**35152**	---	---
Particles >14µm		ASTM D7647	>160	**3027**	---	---
Particles >21µm		ASTM D7647	>40	**670**	---	---
Particles >38µm		ASTM D7647	>10	**33**	---	---
Oil Cleanliness		ISO 4406 (c)	>19/17/14	**24/22/19**	---	---
White Metal	scalar	Visual*	NONE	**VLITE**	---	---
PrtFilter

Light concentration of visible metal present.

There is a high amount of particulates (2 to 100 microns in size) present in the oil.

Viscosity of sample indicates oil is within SAE 10W range, advise investigate. The oil is no longer serviceable as a result of the abnormal and/or severe wear.

Action	Status	Date	Done By	Description
Change Filter	---	---	?	We advise that you perform a filter service, and use off-line filtration to improve the cleanliness of the system fluid.
Resample	---	---	?	Resample in 30-45 days to monitor this situation.
Alert	---	---	?	Little or no information is provided as to the component and lubricant being tested. Recommendations are therefore generic in nature and may not apply to the current application. Please forward information as to equipment type, reservoir capacity, lubricant type and any pertinent information to allow for a more accurate assessment.
Information Required	---	---	?	Please specify the brand, type, and viscosity of the oil on your next sample. NOTE: Please provide information regarding reservoir capacity, filter type and micron rating with next sample.
Check Breathers	---	---	?	The air breather requires service. If unrated, we recommend that you replace with a suitable micron rated and/or desiccant air breather. If rated, we recommend that you service/replace the breather.

Check Dirt Access	---	---	?	We advise that you check all areas where contaminants can enter the system.
Check For Visual Metal	---	---	?	We advise that you check for visible metal particles in the oil.
Filter Fluid	---	---	?	We advise that you perform a filter service, and use off-line filtration to improve the cleanliness of the system fluid.

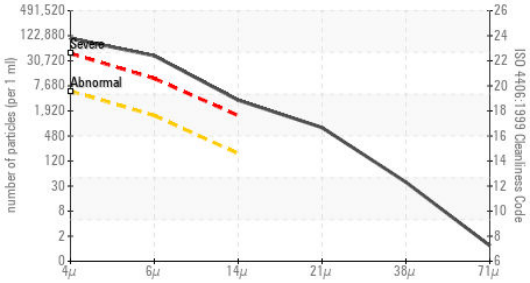
Particle Count

FLUID CLEANLINESS		method	limit/base	current	history1	history2
Particles >4µm		ASTM D7647	>5000	**91643**	---	---
Particles >6µm		ASTM D7647	>1300	**35152**	---	---
Particles >14µm		ASTM D7647	>160	**3027**	---	---
Particles >21µm		ASTM D7647	>40	**670**	---	---
Particles >38µm		ASTM D7647	>10	**33**	---	---
Particles >71µm		ASTM D7647	>3	**1**	---	---
Oil Cleanliness		ISO 4406 (c)	>19/17/14	**24/22/19**	---	---

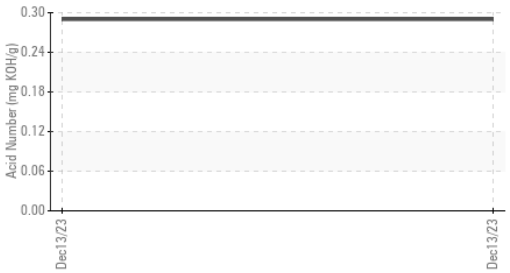
FLUID DEGRADATION		method	limit/base	current	history1	history2
Acid Number (AN)	mg KOH/g	ASTM D974*		**0.29**	---	---

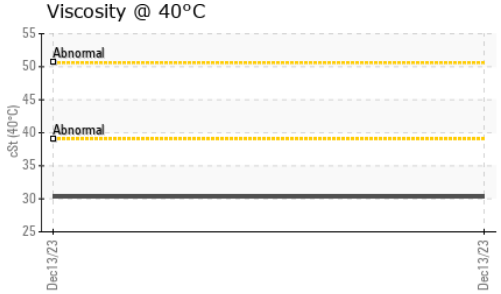
Viscosity @ 40°C

FLUID PROPERTIES		method	limit/base	current	history1	history2
Visc @ 40°C	cSt	ASTM D7279(m)		**30.3**	---	---
