Area
Hyd. shack # 2
Machine Id
Q400#1 (S/N 8424)
Component
Hydraulic System
Fluid
ESSO NUTO H ISO 32 (200 GAL)

Customer Id: FLITOR
Sample No.: WC0777385
Lab Number: 02604124
Test Package: IND 2

OIL ANALYSIS REPORT

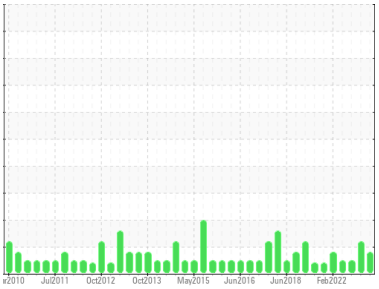
Sample Rating Trend

INSOLUBLES

Sample Status				SEVERE	ATTENTION	NORMAL
MPC Varnish Potential	Scale	ASTM D7843(m)*	>15	63	---	---

We recommend that you use electrostatic filtration to remove insolubles from the oil and to reduce the levels of varnish in the system. Alternatively draining a percentage of the oil and topping up with fresh oil (sweetening the oil) may provide a reduction in the varnish potential level. We recommend an early resample to monitor this condition.

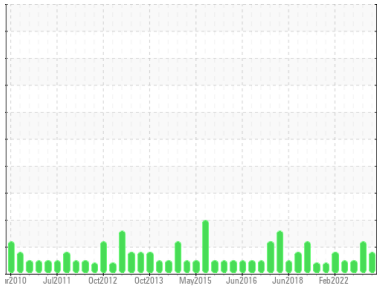
Sample Rating Trend

INSOLUBLES

FLUID DEGRADATION		method	limit/base	current	history1	history2
Acid Number (AN)	mg KOH/g	ASTM D974*	.40	**0.56**	0.53	0.46
MPC Varnish Potential	Scale	ASTM D7843(m)*	>15	**63**	---	---

We recommend that you use electrostatic filtration to remove insolubles from the oil and to reduce the levels of varnish in the system. Alternatively draining a percentage of the oil and topping up with fresh oil (sweetening the oil) may provide a reduction in the varnish potential level. We recommend an early resample to monitor this condition.

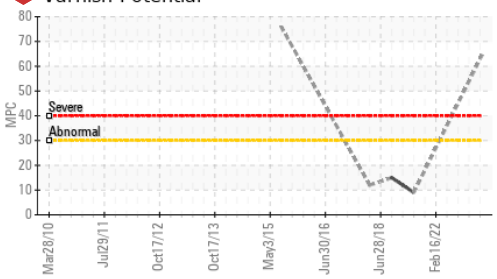
Varnish Potential

MPC (Membrane Patch Colorimetry) test indicates a high concentration of varnish present. The system cleanliness is acceptable for your target ISO 4406 cleanliness code.

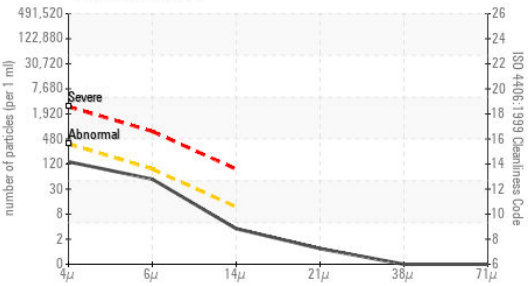
Particle Count

FLUID CLEANLINESS		method	limit/base	current	history1	history2
Particles >4µm		ASTM D7647	>320	**120**	▲ 424	97
Particles >6µm		ASTM D7647	>80	**46**	▲ 107	34
Particles >14µm		ASTM D7647	>10	**3**	5	3
Particles >21µm		ASTM D7647	>3	**1**	2	0
Particles >38µm		ASTM D7647	>3	**0**	1	0
Particles >71µm		ASTM D7647	>3	**0**	1	0
Oil Cleanliness		ISO 4406 (c)	>15/13/10	**14/13/9**	▲ 16/14/10	14/12/9

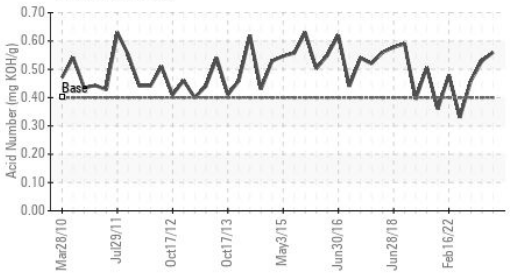
Acid Number

The AN level is acceptable for this fluid.

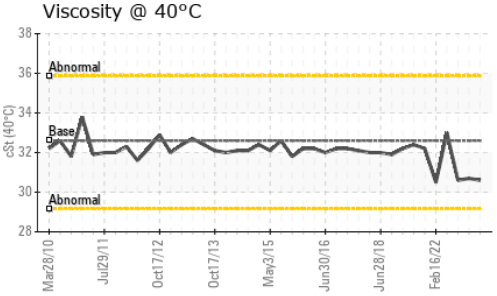
Viscosity @ 40°C

FLUID PROPERTIES		method	limit/base	current	history1	history2
Visc @ 40°C	cSt	ASTM D7279(m)	32.6	**30.6**	30.7	30.6
