OIL ANALYSIS REPORT

Machine Id
#2 Secondary Air Preheater G/B (S/N 31100-HTR-2-A)
Component
Gearbox
Fluid
ESSO SPARTAN EP 220 (59 LTR)

FERROGRAPHY REPORT

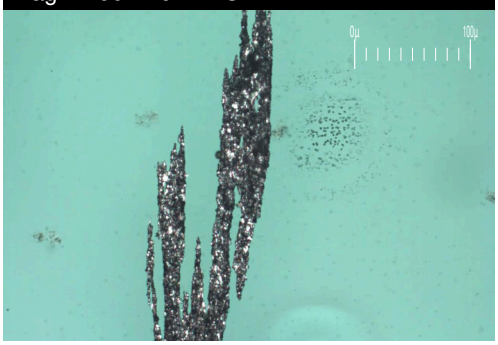
Magn: 200x Illum: BC

All component wear rates are normal. The ferrography results are normal indicating no abnormal wear in the system.
