Customer Id: ONTATI
Sample No.: WC0851403
Lab Number: 02604214
Test Package: IND 1

OIL ANALYSIS REPORT

Machine Id
Clearifer scraper 2 radicon gear box (S/N 012-79170-SCRM2)
Component
Gearbox
Fluid
SHELL TELLUS 68 (--- GAL)

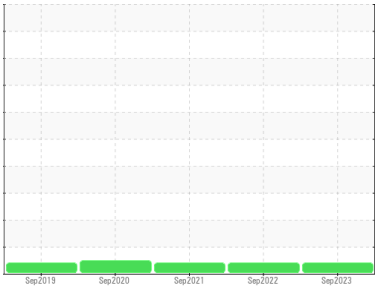
Sample Rating Trend

VISCOSITY

Sample Status				**ABNORMAL**	ABNORMAL	ABNORMAL
Visc @ 40°C	cSt	ASTM D7279(m)	69.43	▲ **449**	▲ 463	▲ 415

Confirm the source of the lubricant being utilized for top-up/fill. Resample at the next service interval to monitor. The fluid was specified as SHELL TELLUS 68, however, a fluid match indicates that this fluid is ISO 460 Gear Oil. Please confirm the oil type and grade on your next sample. NOTE: Please provide information regarding reservoir capacity, filter type and micron rating with next sample.

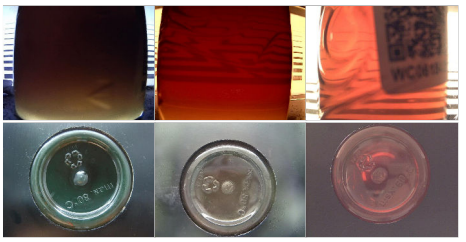
SAMPLE IMAGES	method	limit/base	current	history1	history2
Color					
Bottom

VISUAL		method	limit/base	current	history1	history2
White Metal	scalar	Visual*	NONE	**NONE**	NONE	VLITE
Yellow Metal	scalar	Visual*	NONE	**NONE**	NONE	NONE
Precipitate	scalar	Visual*	NONE	**NONE**	NONE	NONE
Silt	scalar	Visual*	NONE	**NONE**	NONE	NONE
Debris	scalar	Visual*	NONE	**VLITE**	NONE	NONE
Sand/Dirt	scalar	Visual*	NONE	**NONE**	NONE	NONE
Appearance	scalar	Visual*	NORML	**NORML**	NORML	NORML
Odor	scalar	Visual*	NORML	**NORML**	NORML	NORML
Emulsified Water	scalar	Visual*	>0.2	**NEG**	NEG	NEG
Free Water	scalar	Visual*		**NEG**	NEG	NEG
