OIL ANALYSIS REPORT

Area
[64423]
Machine Id
VOLVO VNL 4430
Component
Diesel Engine
Fluid
PETRO CANADA DURON SAE 10W30 (--- GAL)

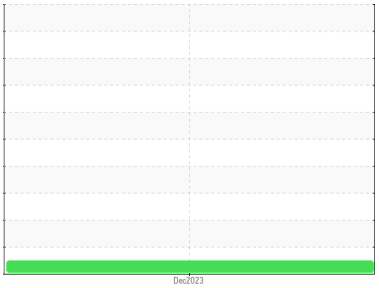
Sample Rating Trend

NORMAL

Wear
Metal levels are typical for a new component breaking in.

Contamination
There is no indication of any contamination in the oil.

Fluid Condition
The condition of the oil is acceptable for the time in service.

Recommendation
Resample at the next service interval to monitor.
