PROBLEM SUMMARY

Area
[02437560]
Machine Id
A1 - Thrust Bearing
Component
Thrust Bearing
Fluid
PETRO CANADA TURBOFLO R&O 46 (4920 LTR)

OIL ANALYSIS REPORT

FERROGRAPHY REPORT

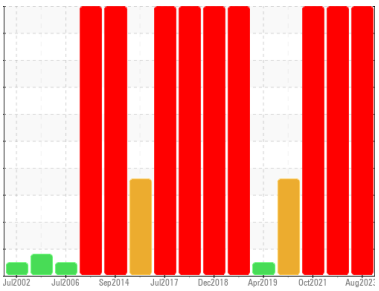
Sample Rating Trend

CONTAMINANT

Sample Status				**SEVERE**	SEVERE	SEVERE
Lead	ppm	ASTM D5185(m)	>60	▲ **21**	12	7
Copper	ppm	ASTM D5185(m)	>7	▲ **2**	<1	<1
Anti-Oxidant 2	%	ASTM D6971*	<25	▲ **21**	40	66
Separability	oil/h2o/em	ASTM D1401*	41/39/0	⬢ **0/0/80 (30)**	⬢ 0/2/78 (30)	⬢ 2/4/74 (30)
PrtFilter

We recommend that you perform vacuum distillation and/or air drying to attempt to remove any residual water and/or entrained gases from this oil that may be contributing to abnormal foaming and/or poor water separability. We recommend an early resample to monitor this condition.

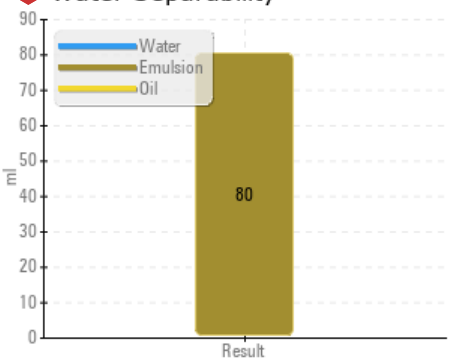
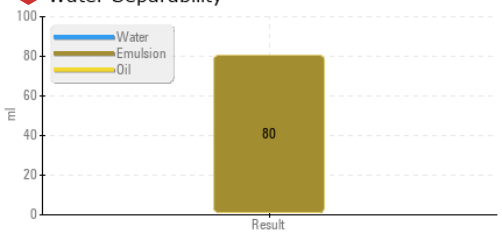
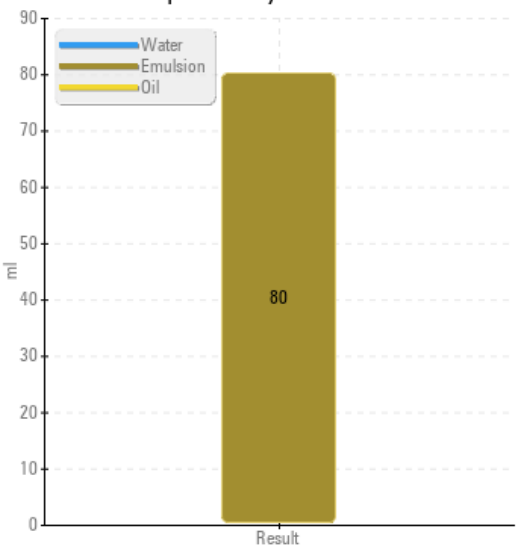
Water Separability results (ASTM D1401) are poor and indicate that the oil will form emulsions with water. The system cleanliness is acceptable for your target ISO 4406 cleanliness code. The water content is negligible.

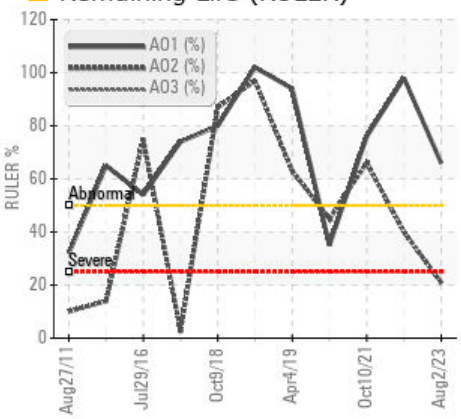
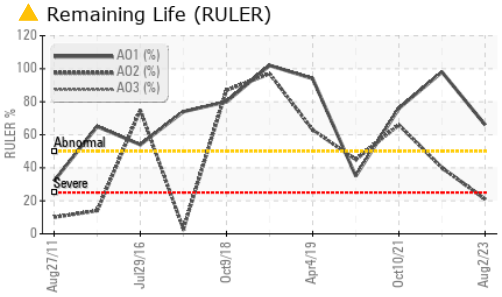
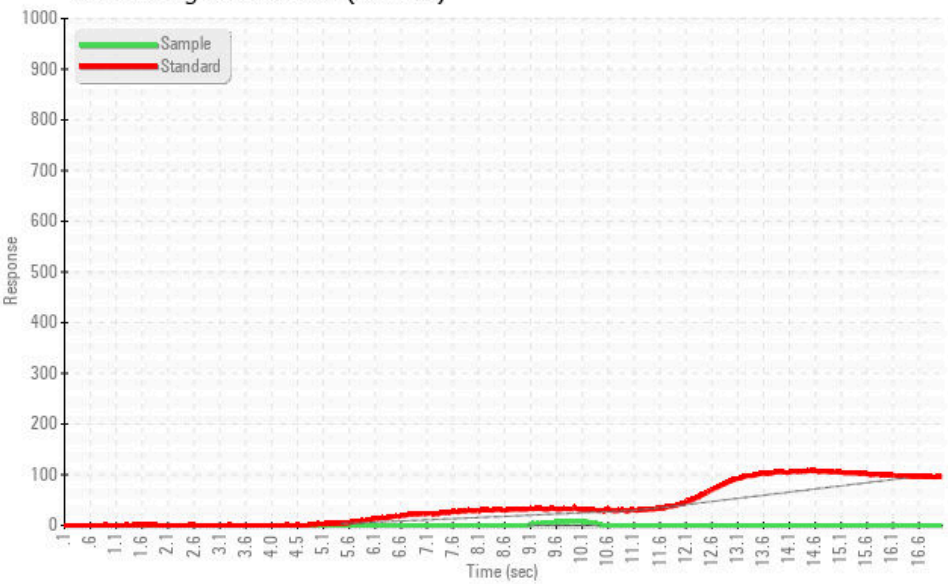
Remaining Life (RULER)

Linear Sweep Voltammetry (RULER– ASTM D6971) testing indicates a low amount of one of the anti-oxidants present in the oil, however, the other anti-oxidant(s) are still performing adequately. Rust Prevention test (ASTM D665) indicates the oil retains good anti-corrosion properties. The AN level is acceptable for this fluid.

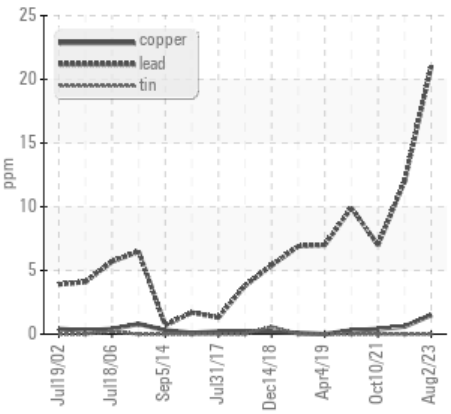
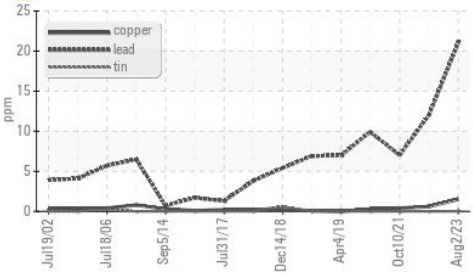
Non-ferrous Metals

Copper and lead ppm levels are marginal. Bearing and/or bushing wear is indicated. All other component wear rates are normal. The ferrography results are normal indicating no abnormal wear in the system.

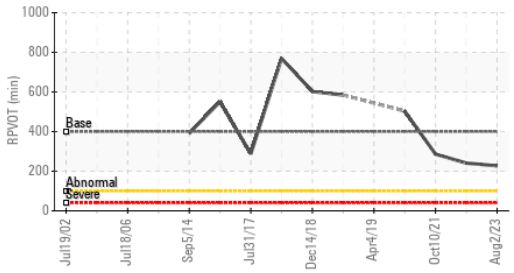
RPVOT

FLUID PROPERTIES		method	limit/base	current	history1	history2
Visc @ 40°C	cSt	ASTM D7279(m)	44.4	**45.0**	45.0	45.5
Visc @ 100°C	cSt	ASTM D7279(m)	6.72	**6.7**	6.8	6.8
Viscosity Index (VI)	Scale	ASTM D2270*	104	**101**	105	103
Separability	oil/h2o/em	ASTM D1401*	41/39/0	⬢ **0/0/80 (30)**	⬢ 0/2/78 (30)	⬢ 2/4/74 (30)
Air Release Time	min	ASTM D3427*	3.5	**4.10**	4.40	2.90
Foam Tendency	I/II/III	ASTM D892*	10	**410/25/390**	440/10/40	340/20/50
Foam Stability	I/II/III	ASTM D892*	0	**0/0/0**	0/0/0	0/0/0
ASTM Color	scalar	ASTM D1500*	0.5	**<1.0**	<1.0	<1.0
Rust Prevention	PASS/FAIL	ASTM D665*	PASS	**PASS**	PASS	PASS
Oxidation Test (RPVOT)	minutes	ASTM D2272*	400	**227**	241	286

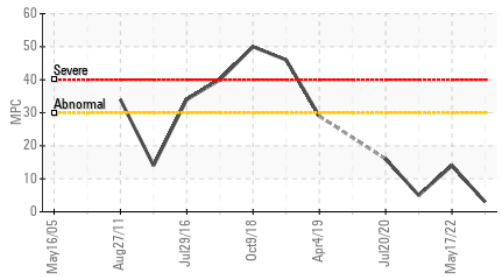
FLUID DEGRADATION		method	limit/base	current	history1	history2
Oxidation	Abs/.1mm	ASTM D7414*		**2.3**	2.9	2.6
Acid Number (AN)	mg KOH/g	ASTM D974*	0.12	**0.07**	0.06	0.06
Anti-Oxidant 1	%	ASTM D6971*	<25	**66**	98	76
Anti-Oxidant 2	%	ASTM D6971*	<25	▲ **21**	40	66
MPC Varnish Potential	Scale	ASTM D7843(m)*	>15	**3**	14	5

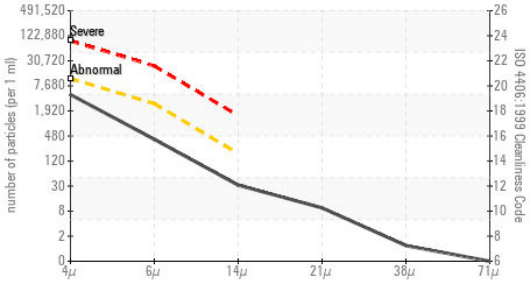
Particle Count

FLUID CLEANLINESS		method	limit/base	current	history1	history2
Particles >4µm		ASTM D7647	>10000	**4123**	▲ 15289	8427
Particles >6µm		ASTM D7647	>2500	**351**	1312	784
Particles >14µm		ASTM D7647	>160	**28**	42	18
Particles >21µm		ASTM D7647	>40	**8**	11	3
Particles >38µm		ASTM D7647	>10	**1**	1	0
Particles >71µm		ASTM D7647	>3	**0**	1	0
Oil Cleanliness		ISO 4406 (c)	>20/18/14	**19/16/12**	▲ 21/18/13	20/17/11

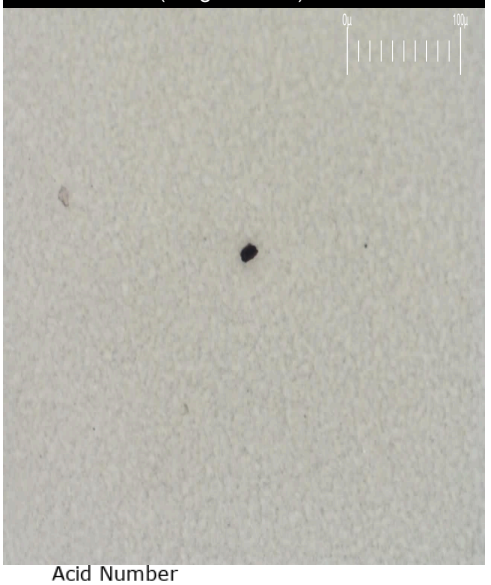
Particle Filter (Magn: 200 x)

Copper and lead ppm levels are marginal. Bearing and/or bushing wear is indicated. All other component wear rates are normal. The ferrography results are normal indicating no abnormal wear in the system.
