OIL ANALYSIS REPORT

Machine Id
TIMM #1 PLUNGER 3
Component
Gearbox
Fluid
SHELL OMALA S2 G 68 (--- GAL)

FERROGRAPHY REPORT

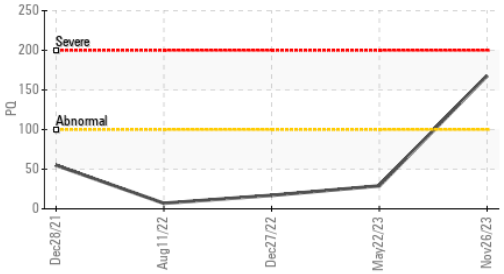
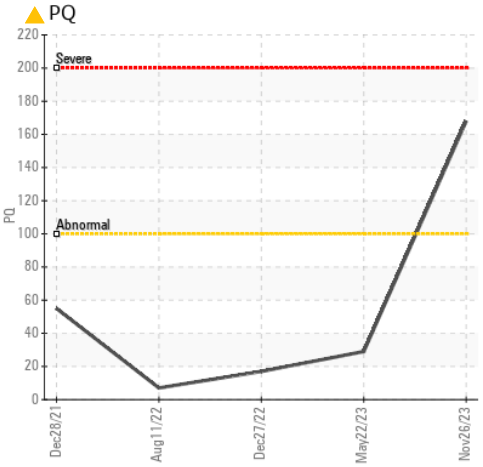
Wear
PQ levels are abnormal. Iron ppm levels are abnormal. Gear wear is indicated. The high ferrous density (PQ) index indicates that abnormal wear is occurring. The ferrography results are normal indicating no abnormal wear in the system.

Recommendation
The oil change at the time of sampling has been noted. We recommend an early resample to monitor this condition. NOTE: Please provide information regarding reservoir capacity, filter type and micron rating with next sample.

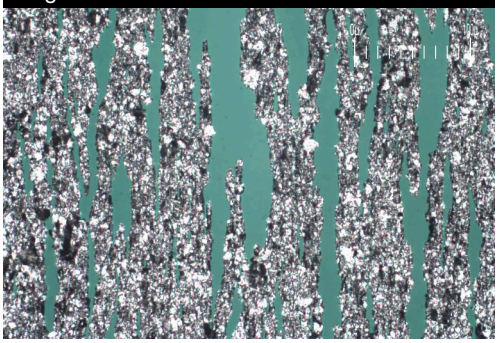
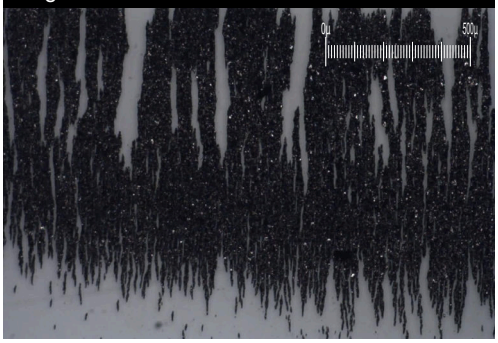
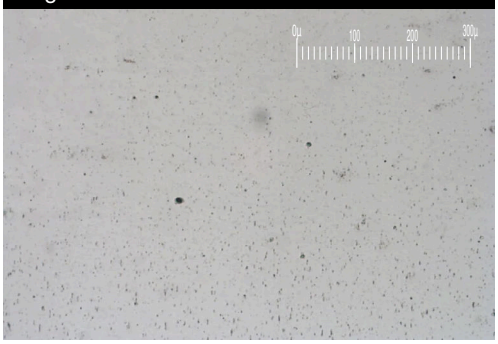
PQ levels are abnormal. Iron ppm levels are abnormal. Gear wear is indicated. The high ferrous density (PQ) index indicates that abnormal wear is occurring. The ferrography results are normal indicating no abnormal wear in the system.
