OIL ANALYSIS REPORT

Area
REAL PROPERTY SHIPPAGAN [70558]
Machine Id
74767330
Component
Diesel Engine
Fluid
VALVOLINE 15W40 (--- GAL)

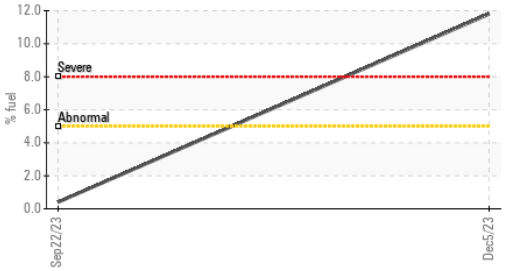
Fuel Dilution

Contamination
There is a high amount of fuel present in the oil. Tests confirm the presence of fuel in the oil.

Fluid Condition
Fuel is present in the oil and is lowering the viscosity. The oil is no longer serviceable due to the presence of contaminants.

Recommendation
We advise that you check the fuel injection system. We recommend that you drain the oil from the component if this has not already been done. We recommend an early resample to monitor this condition.

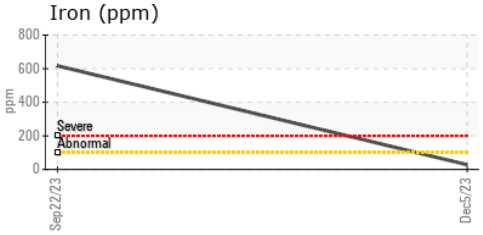
Iron (ppm)

Wear
Metal levels are typical for a new component breaking in.
