Customer Id: HIBSTJ
Sample No.: WC0861476
Lab Number: 02606103
Test Package: MAR 2

OIL ANALYSIS REPORT

Area
System 56 - Hazardous Drains
Machine Id
Z-5601B Centrifuge Gearbox Lube Oil
Component
Gearbox
Fluid
GEAR OIL ISO 320 (13 LTR)

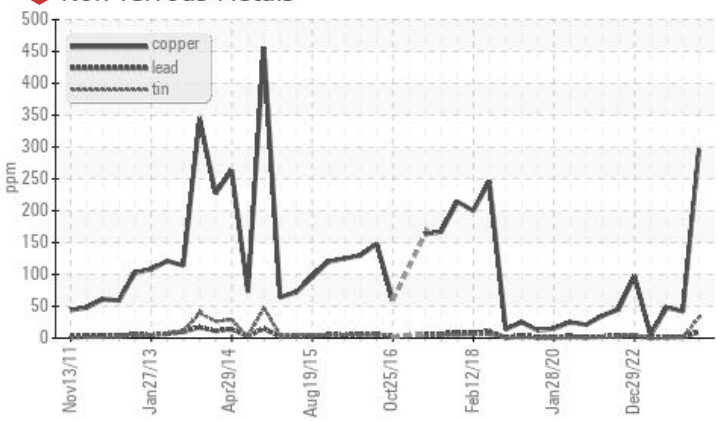
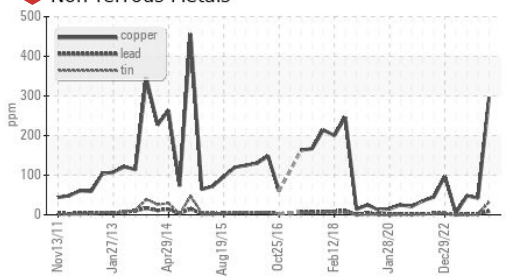
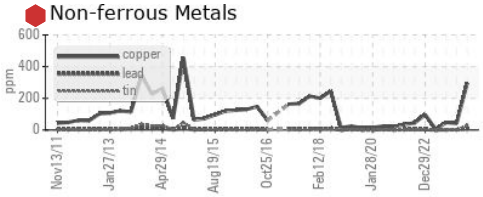
Non-ferrous Metals

Sample Status				SEVERE	ABNORMAL	ABNORMAL
Copper	ppm	ASTM D5185(m)	>80	**296**	42	48
Tin	ppm	ASTM D5185(m)	>8	**32**	1	<1
Particles >4µm		ASTM D7647	>20000	**258866**	129380	147853
Particles >6µm		ASTM D7647	>5000	**141754**	24750	30616
Particles >14µm		ASTM D7647	>640	**1909**	198	191
Oil Cleanliness		ISO 4406 (c)	>21/19/16	**25/24/18**	24/22/15	24/22/15

Copper and tin ppm levels are severe.

Check seals and/or filters for points of contaminant entry. The air breather requires service. If unrated, we recommend that you replace with a suitable micron rated and/or desiccant air breather. If rated, we recommend that you service/replace the breather. We recommend you service the filters on this component. Resample in 30-45 days to monitor this situation. Please specify the brand, type, and viscosity of the oil on your next sample.

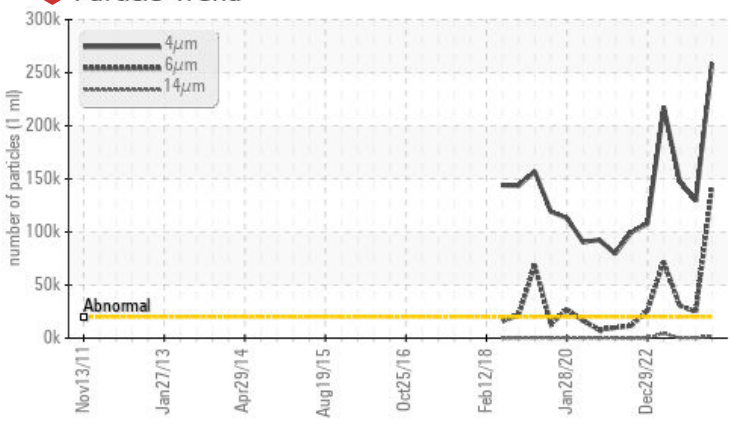
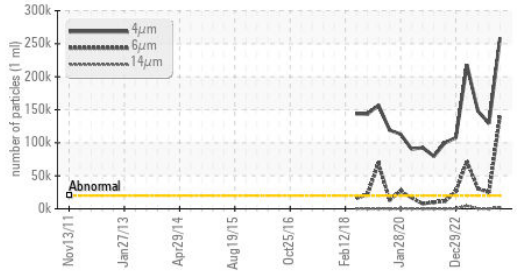
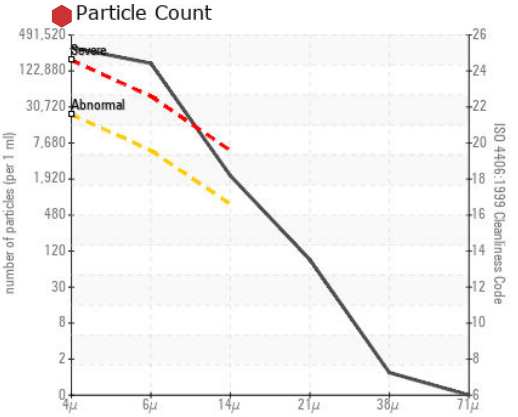
Particle Trend

There is a high amount of silt (particulates < 14 microns in size) present in the oil. The water content is negligible.

FLUID CLEANLINESS		method	limit/base	current	history1	history2
Particles >4µm		ASTM D7647	>20000	**258866**	129380	147853
Particles >6µm		ASTM D7647	>5000	**141754**	24750	30616
Particles >14µm		ASTM D7647	>640	**1909**	198	191
Particles >21µm		ASTM D7647	>160	**76**	31	46
Particles >38µm		ASTM D7647	>40	**1**	6	4
Particles >71µm		ASTM D7647	>10	**0**	5	2
Oil Cleanliness		ISO 4406 (c)	>21/19/16	**25/24/18**	24/22/15	24/22/15

Action	Status	Date	Done By	Description
Change Filter	---	---	?	We recommend you service the filters on this component.
Resample	---	---	?	Resample in 30-45 days to monitor this situation.
Information Required	---	---	?	Please specify the brand, type, and viscosity of the oil on your next sample.
Check Breathers	---	---	?	The air breather requires service. If unrated, we recommend that you replace with a suitable micron rated and/or desiccant air breather. If rated, we recommend that you service/replace the breather.
Check Seals	---	---	?	Check seals and/or filters for points of contaminant entry.

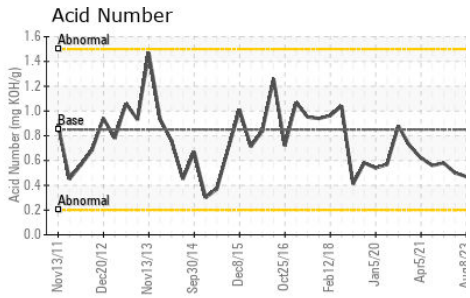
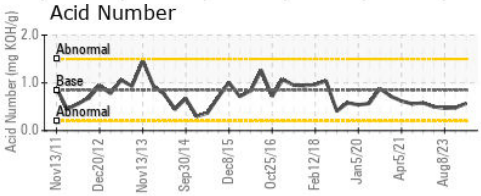
Acid Number

The AN level is acceptable for this fluid. The oil is no longer serviceable as a result of the abnormal and/or severe wear.
