OIL ANALYSIS REPORT

Area
IPEX - 888063
Machine Id
AM962
Component
Hydraulic System
Fluid
AW HYDRAULIC OIL ISO 46 (--- GAL)

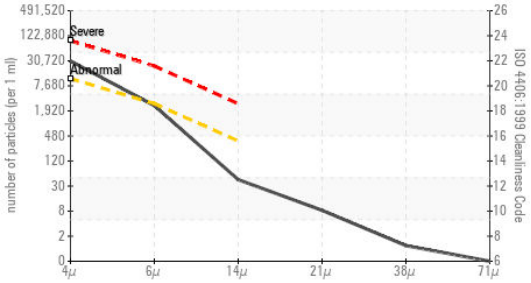
Particle Count

Contamination
Particles >4µm and oil cleanliness are abnormally high.

FLUID CLEANLINESS		method	limit/base	current	history1	history2
Particles >4µm		ASTM D7647	>10000	▲ **26389**	---	---
Particles >6µm		ASTM D7647	>2500	**2256**	---	---
Particles >14µm		ASTM D7647	>320	**38**	---	---
Particles >21µm		ASTM D7647	>80	**7**	---	---
Particles >38µm		ASTM D7647	>20	**1**	---	---
Particles >71µm		ASTM D7647	>4	**0**	---	---
Oil Cleanliness		ISO 4406 (c)	>20/18/15	▲ **22/18/12**	---	---

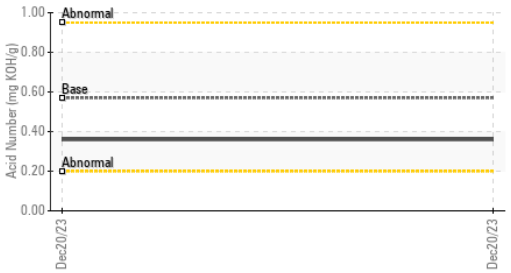
FLUID DEGRADATION		method	limit/base	current	history1	history2
Acid Number (AN)	mg KOH/g	ASTM D974*	0.57	**0.36**	---	---
