OIL ANALYSIS REPORT

Area
Global Plas - G06200
Machine Id
AG209
Component
Hydraulic System
Fluid
{not provided} (--- GAL)

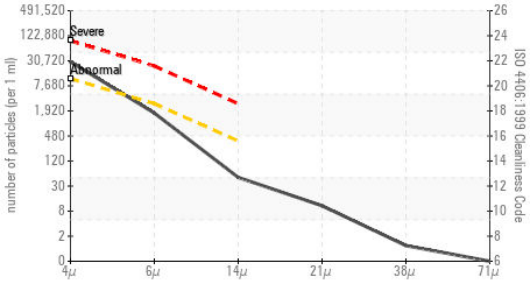
Particle Count

Contamination
Particles >4µm and oil cleanliness are abnormally high.

FLUID CLEANLINESS		method	limit/base	current	history1	history2
Particles >4µm		ASTM D7647	>10000	▲ **25274**	---	---
Particles >6µm		ASTM D7647	>2500	**1492**	---	---
Particles >14µm		ASTM D7647	>320	**43**	---	---
Particles >21µm		ASTM D7647	>80	**9**	---	---
Particles >38µm		ASTM D7647	>20	**1**	---	---
Particles >71µm		ASTM D7647	>4	**0**	---	---
Oil Cleanliness		ISO 4406 (c)	>20/18/15	▲ **22/18/13**	---	---
