OIL ANALYSIS REPORT

Area
IAC-Maple - L01500
Machine Id
A2401013
Component
Hydraulic System
Fluid
{not provided} (--- GAL)

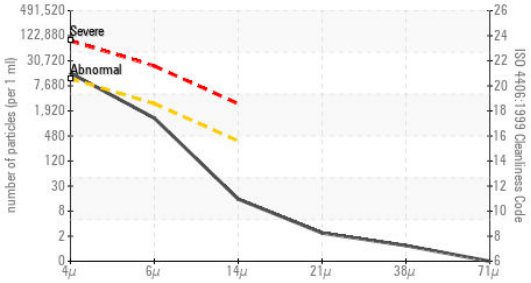
Particle Count

Contamination
Particles >4µm and oil cleanliness are notably high. The sample submitted is 4 times dirtier than the ISO dirt count recommendation of 19/16/14.

FLUID CLEANLINESS		method	limit/base	current	history1	history2
Particles >4µm		ASTM D7647	>10000	▲ **13533**	---	---
Particles >6µm		ASTM D7647	>2500	**1131**	---	---
Particles >14µm		ASTM D7647	>320	**13**	---	---
Particles >21µm		ASTM D7647	>80	**2**	---	---
Particles >38µm		ASTM D7647	>20	**1**	---	---
Particles >71µm		ASTM D7647	>4	**0**	---	---
Oil Cleanliness		ISO 4406 (c)	>20/18/15	▲ **21/17/11**	---	---
