Area
IAC-Maple - L01500
Machine Id
A2401020
Component
Hydraulic System
Fluid
{not provided} (--- GAL)

Customer Id: CHECOB
Sample No.: E30001096
Lab Number: 02606798
Test Package: IND 2

OIL ANALYSIS REPORT

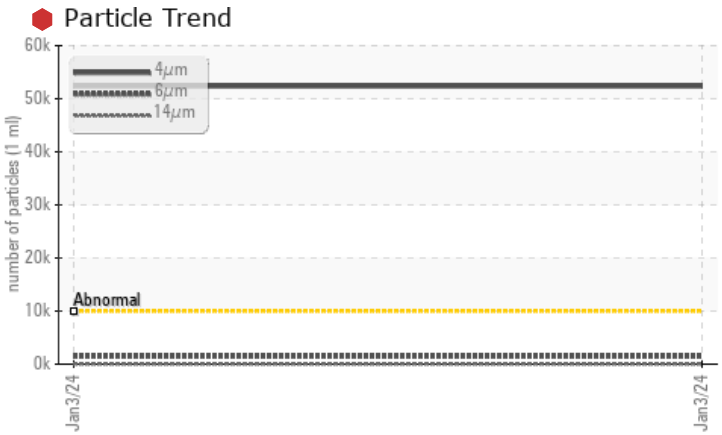
COMPONENT CONDITION SUMMARY

Sample Status				**SEVERE**	---	---
Particles >4µm		ASTM D7647	>10000	**52351**	---	---
Oil Cleanliness		ISO 4406 (c)	>20/18/15	**23/18/12**	---	---

Contamination
Particles >4µm and oil cleanliness are abnormally high.
The sample submitted is 16 times dirtier than the ISO dirt count recommendation of 19/16/14.

This is a baseline read-out on the submitted sample.

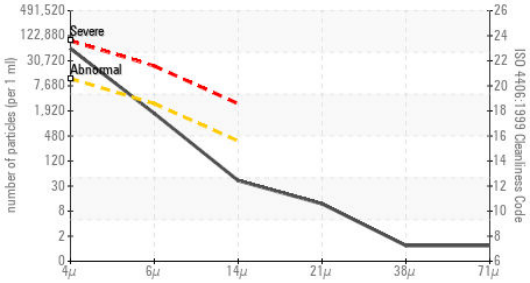
Particle Count

FLUID CLEANLINESS		method	limit/base	current	history1	history2
Particles >4µm		ASTM D7647	>10000	**52351**	---	---
Particles >6µm		ASTM D7647	>2500	**1460**	---	---
Particles >14µm		ASTM D7647	>320	**36**	---	---
Particles >21µm		ASTM D7647	>80	**10**	---	---
Particles >38µm		ASTM D7647	>20	**1**	---	---
Particles >71µm		ASTM D7647	>4	**1**	---	---
Oil Cleanliness		ISO 4406 (c)	>20/18/15	**23/18/12**	---	---

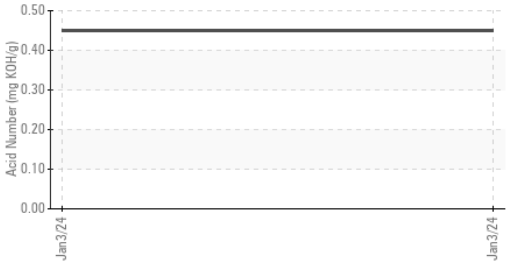
FLUID DEGRADATION		method	limit/base	current	history1	history2
Acid Number (AN)	mg KOH/g	ASTM D974*		**0.45**	---	---
